Beware insulation tucks, folds and gaps

It's widely known that tucks, folds and gaps in insulation reduces its thermal performance, so correct installation is important. Now, BRANZ is aiming to quantify exactly what impact poor installation has on a house's performance.

By **Ian Cox-Smith**, BRANZ Building Physicist

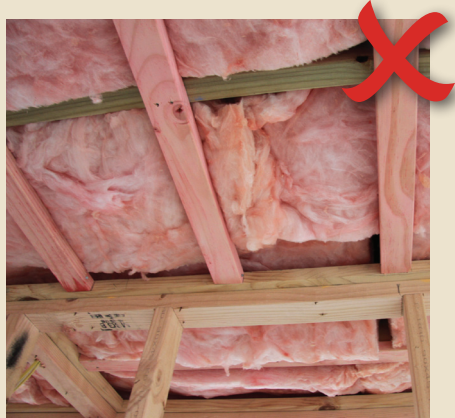
Ceiling insulation gaps are the most common fault (see Figure 1). There are, inevitably, also a few areas where the insulation should be installed more carefully, including:

Figure 1: Gaps in ceiling insulation is the most common fault.

Ceiling insulation often has an air space between the ceiling and the underside of the insulation, so gaps around the edges of the insulation are much more detrimental than they are around wall insulation that completely fills the space between the cladding and lining. Convective heat transfer is able to carry heat away from the entire back surface of ceiling lining.

Poorly installed ceiling insulation often results from the new method of using poles to push insulation into place from below, rather than the traditional method of installing from above after the ceiling lining is in place. The pole method was introduced after polyester and wool insulation became available in roll form but segmented products still require the follow-up use of a ladder to fit the material well.

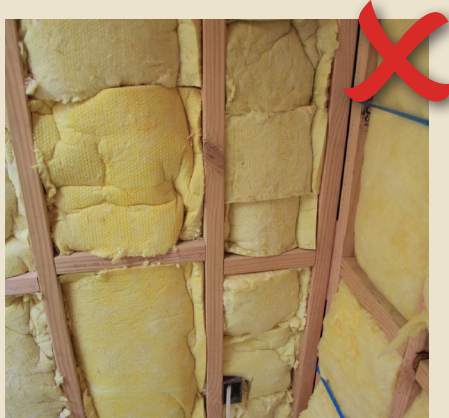
In Figure 2, this happened due to the relatively high cost and large volume R2.8 insulation product being used.

Figure 2: Small pieces of leftover insulation fill a frame space.

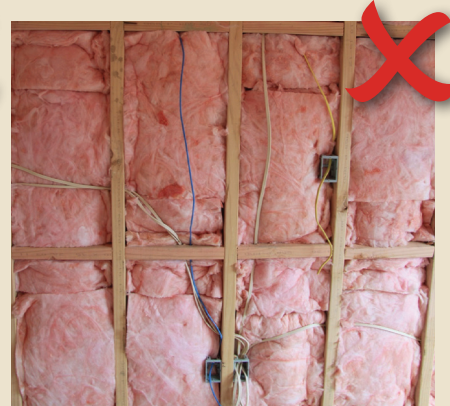
Figure 3: Inadequate supervision resulted in this poor installation around electrical wiring.

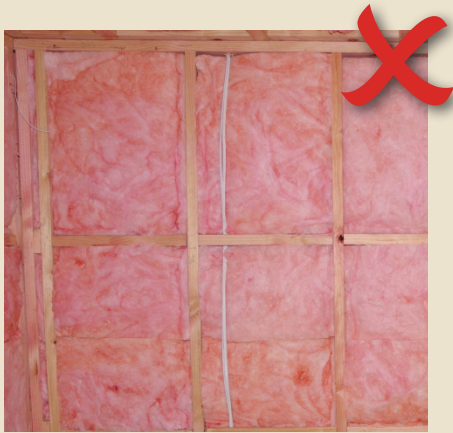
In Figure 4, nearly all the frame spaces have at least one edge of the insulation tucked.

There is also a significant gap between the insulation and the top plate in one of the top centre frame spaces.

Figure 4: This installation looks OK, but nearly all the frame spaces have at least one edge of tucked insulation.

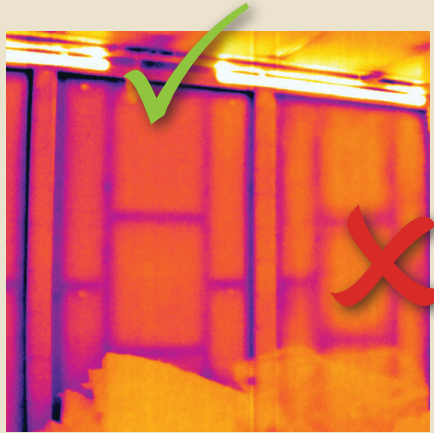
Figure 5: Thermal image of two panels in BRANZ research building. The left panel has no tucks in the insulation, the right has tucks.

With tucks, an R2.2 insulation product was performing as if it was an R2.0 product. Removing the tucks increased the performance of the insulation to its intended R2.2.

Overall, when the framing, cladding, and lining are taken into account, the 10% reduction in the R-value of the insulation material resulted in a 5% reduction in the R-value of the wall panel.

Figure 5 shows a thermal image of two of the wall panels. The one on the left has had the tucks in the insulation removed while the one on the right is the panel before the tucks were removed.

When there are no tucks, the framing is in sharp contrast to the insulation, but when tucks are present, the thermal signature of the framing is smeared. ◀

The originally installed insulation in one wall had tucks on most edges, so the insulation was removed, cut down to the correct size, then reinstalled without tucks and the R-value measured again.
