How did houses perform?

BRANZ research shows that houses built to the current Building Code and standards generally stood up well to the Canterbury earthquakes. However, more complex specifically designed houses often had issues.

BY GRAEME BEATTIE, BRANZ PRINCIPAL STRUCTURAL ENGINEER, AND ROGER SHELTON, BRANZ SENIOR STRUCTURAL ENGINEER

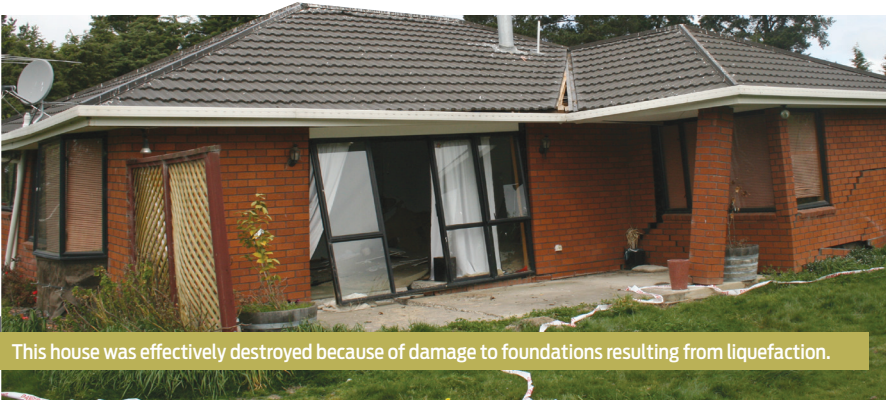
This house was effectively destroyed because of damage to foundations resulting from liquefaction.

Many of the perimeter concrete foundation walls supported heavy brick or block claddings and heavy concrete or clay tile roofs. When the liquefaction was severe, these walls settled into the ground at a greater rate than the more lightly loaded piles, resulting in a badly distorted house.

The Engineering Advisory Group has developed a range of more robust foundation systems for new houses on properties where there is a likelihood of liquefaction in future earthquakes. Some foundations are expected to accommodate the associated ground distortions with minimal distortion of the house - stiff rafts - while others have been designed so that relevening is a relatively easy process - suspended timber floors.

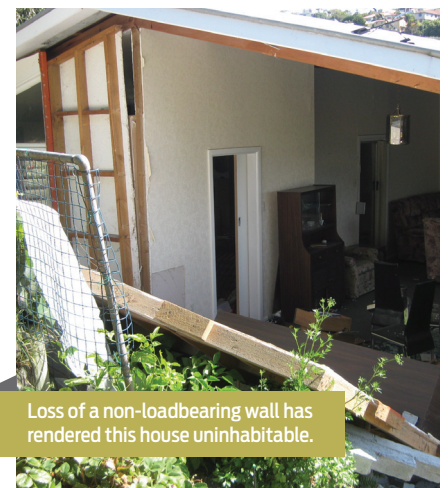
Loss of a non-loadbearing wall has rendered this house uninhabitable.
