# Fire protection

An investigation into the performance of fire protection systems in the Christchurch earthquakes produced recommendations for change.

BY PETER COLLIER, BRANZ SENIOR FIRE RESEARCH ENGINEER, AND GREG BAKER, BRANZ FIRE AND STRUCTURAL ENGINEERING MANAGER

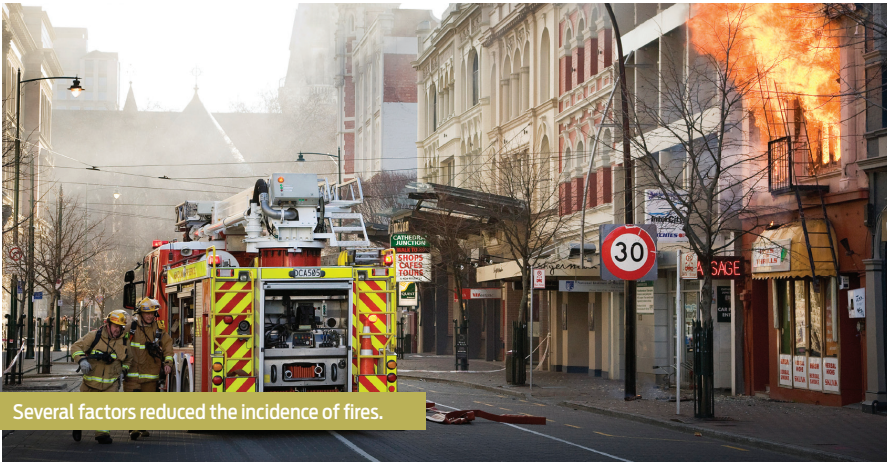
Several factors reduced the incidence of fires.

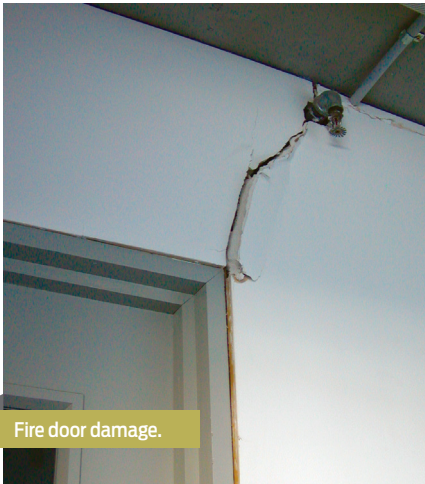
In some buildings, the passive fire protection was destroyed. This research focused on structurally safe buildings where the passive fire protection had been damaged.

- fire-rated lining cracked or separated from fire door framing
- door leaf movement opening a 4-16 mm gap down the door frame (rather than 2-3 mm)
- a wall-to-wall internal corner junction with a 15 mm gap in a fire-rated escape stairwell
- a precast concrete stair where the junction to the fire-rated wall beneath had been crushed by earthquake-induced motion.
