BY ROGER SHELTON,  
BRANZ SENIOR  
STRUCTURAL ENGINEER

# Retrofitting timber house foundations on sloping sites

Houses built on sloping sites have performed poorly in recent earthquakes. BRANZ experiments have shown how to retrofit pre-1960s timber house foundations to significantly improve seismic performance.

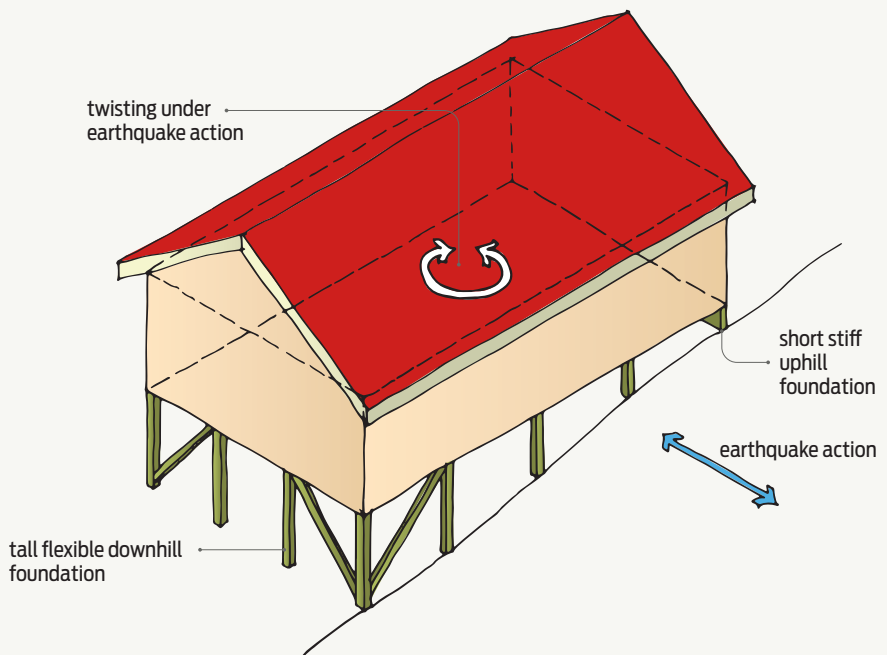
Under earthquake action across the slope, there is potential for large displacements on the tall flexible foundation structure on the downslope edge of the building, causing it to twist about the squatter, stiffer uphill foundation (Figure 1).

The deflections from the twisting action adds to the lateral displacement, potentially resulting in a progressive rotational failure. This difference in stiffness and the potential torsional problem is not addressed in NZS 3604:2011 *Timber-framed buildings*, where only the foundation's strength is considered, nor in a specific engineering design if only strength is considered.

**Figure 1** Twisting of floor on hillside under earthquake action.

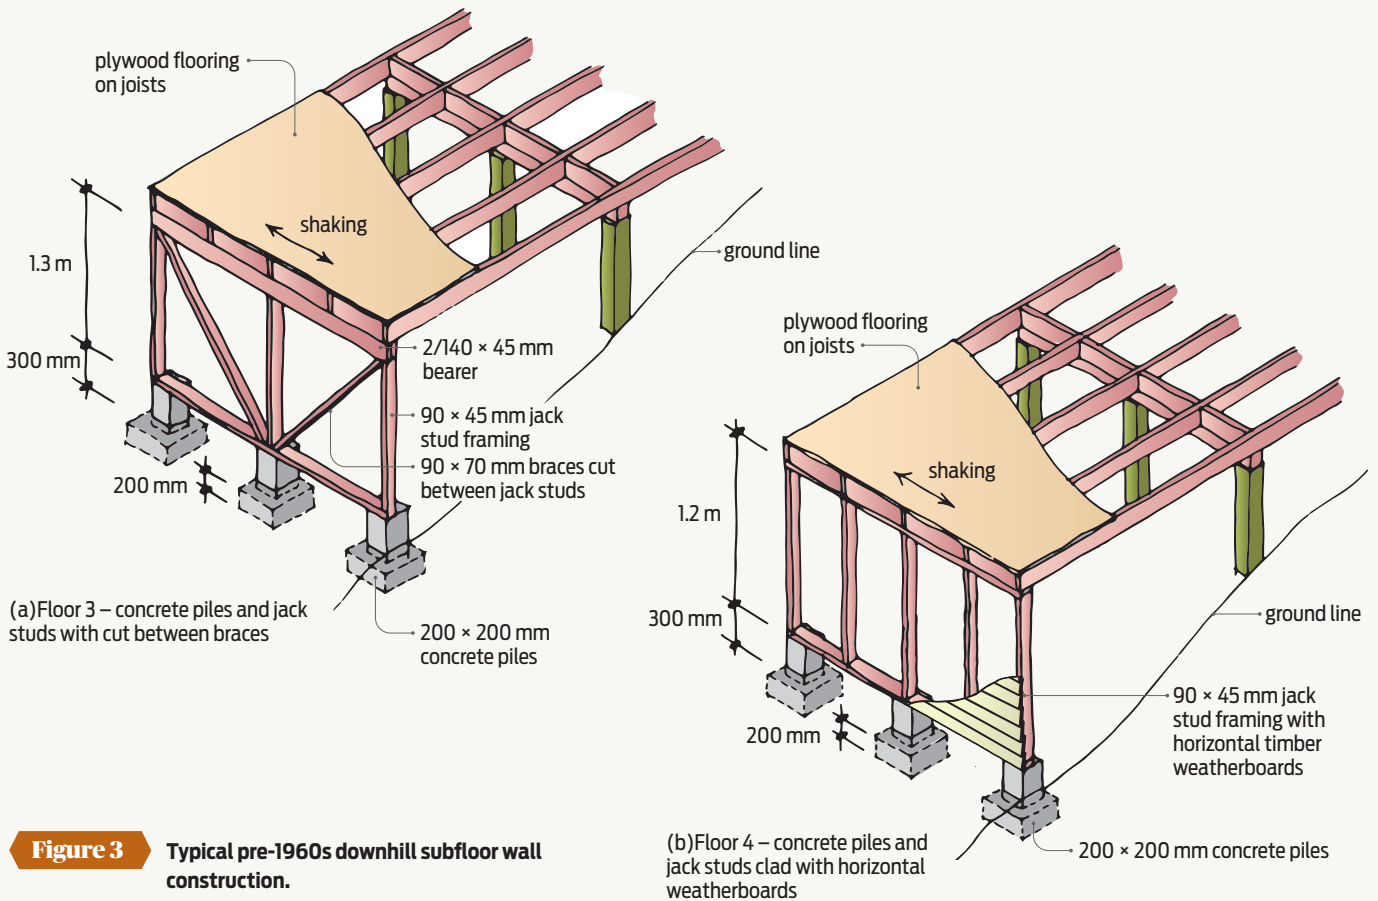
- Floor 3 – typical pre-1960s construction using concrete piles and jack studs with cut between braces (see Figure 3a).
- Floor 4 – typical pre-1960s construction using concrete piles and jack studs and clad with horizontal timber weatherboards (see Figure 3b).

**Figure 3** Typical pre-1960s downhill subfloor wall construction.

During the shaking, deflections of the pre-1960s floors increased, almost to the point of imminent collapse in one test. To address this, the pre-1960s foundations were retrofitted to improve their performance:

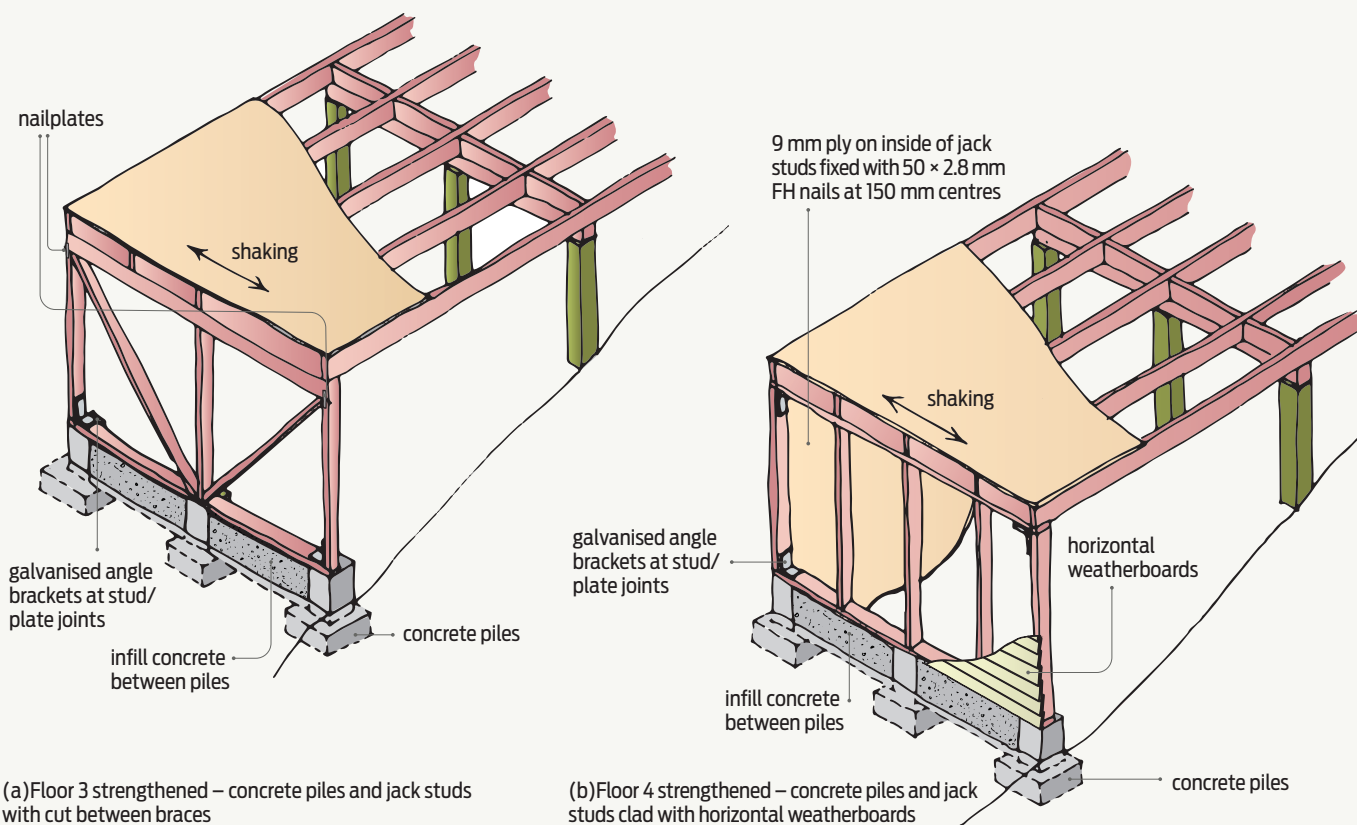
**Figure 4** Pre-1960s downhill subfloor wall construction after strengthening.

- Both floors 3 and 4 had infill concrete foundation walls cast between the existing piles (see Figure 4a and 4b).
- Floor 3 had all frame joints strengthened with the installation of galvanised brackets at all stud to plate joints (Figure 4a).
- Floor 4 had sheets of 9 mm plywood nailed to the inside face of the jack stud wall (see Figure 4b).

The infill foundation walls were very effective at stabilising the isolated pile foundations, although these could be difficult to construct on sites with limited underfloor access.

Nominal reinforcement was used in the wall, together with grouted in starters to all the piles. In the interests of buildability, starters could be reduced to end piles only as the centre piles are book-ended by foundation walls on each side.

The ply sheeting was very straightforward to install, as were the extra connectors on the jack stud braces. All solutions are likely to be inexpensive for most residential foundations. ◀

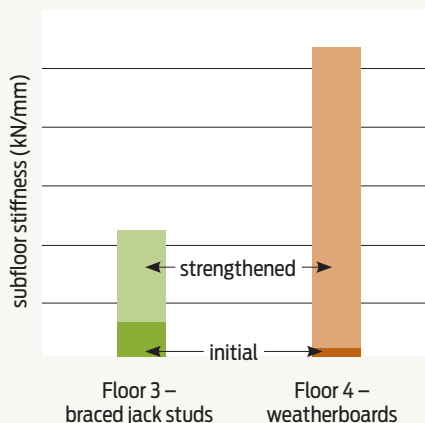
**Figure 5** Change in relative stiffness of pre-1960s downhill walls after strengthening.

Under the initial shaking, the pre-1960s floor structures proved to be quite flexible. However, after retrofitting, they stiffened up considerably, as anticipated by the measurements taken in the preliminary tests. Figure 5 shows the relative

stiffness and the increase in relative stiffness in both pre-1960s foundations.
