BRICK VENEER OVER HABITABLE SPACES

Some external moisture is likely to penetrate masonry veneer, but this isn't a problem when sufficient ventilation can drain and dry any water that enters. In this example, poor construction details restricted ventilation and caused problems.

By Alide Elkink, Freelance Technical Writer, Wellington

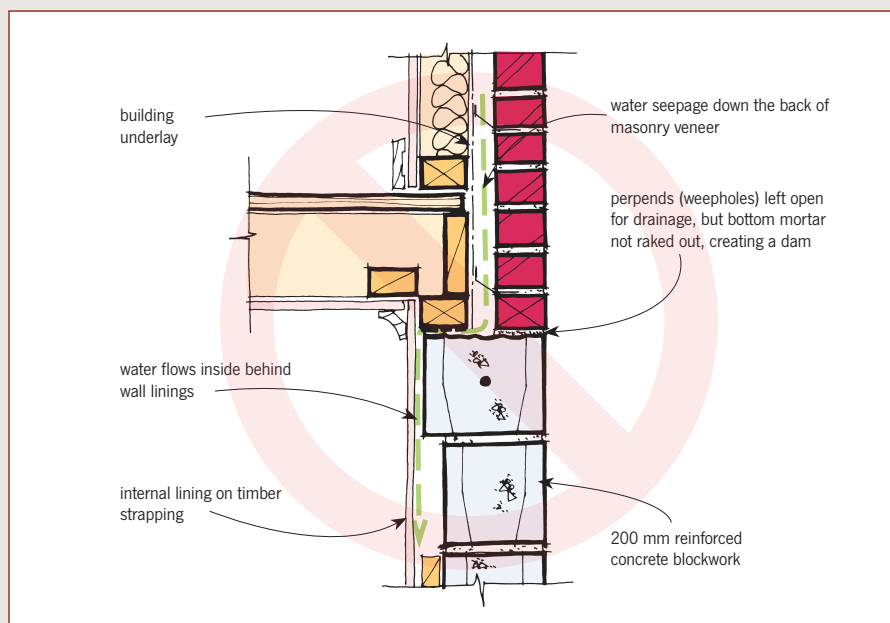
Figure 1: The problem – faulty installation of masonry veneer.

During pressure hosing, starting at the bottom of the wall and working up, leakage was induced when the masonry veneer (upper level) was hosed. The removal of a section of the lowest course of the brick veneer finally revealed the problem (see Figure 1).

The brick veneer and timber framing had been built directly on top of the concrete-filled masonry wall. Weepholes had been incorporated in the bottom course of bricks, but no 50 mm step-down had been created to keep the timber framing clear of the cavity drainage area. To make things worse, mortar droppings had been left in the cavity, resulting in a →

build-up of mortar that blocked the weepholes. Instead of draining out through the weepholes, the water that penetrated the masonry veneer was directed back towards the framing and then down the inside face of the masonry block wall.

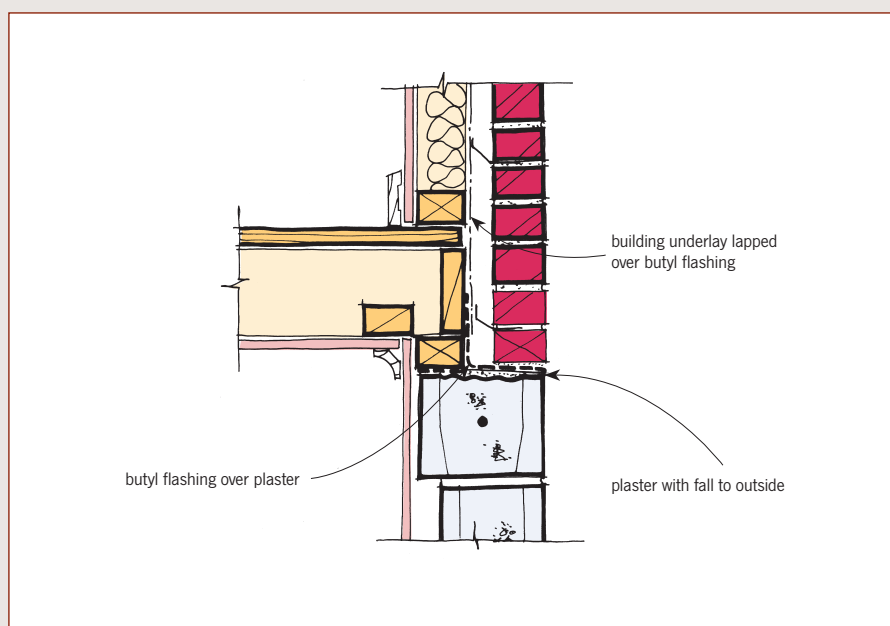
Figure 2: Solution for this case study.

Because this was a repair, it was not possible to build a step-down at the base of the wall.

To fix the problem, the lowest two courses of the brick veneer were progressively removed from around the building and the veneer above temporarily supported with timber blocks (although sections will stand without support). The debris at the top of the concrete masonry wall was removed, and a thin layer of plaster was applied to the top of the wall to create a smooth finish with a slight fall to the outside face of the building (see Figure 2).

A 1 mm thick, butyl rubber flashing was laid over the plastered top of the concrete block wall and turned up against the timber frame at the back of the cavity, ensuring that the building underlay on the exterior face of the timber frame lapped over the top of the flashing, which was then stapled to the framing. The flashing was installed in continuous lengths with lapped and glued joints only at corners and where it was necessary to change direction only.

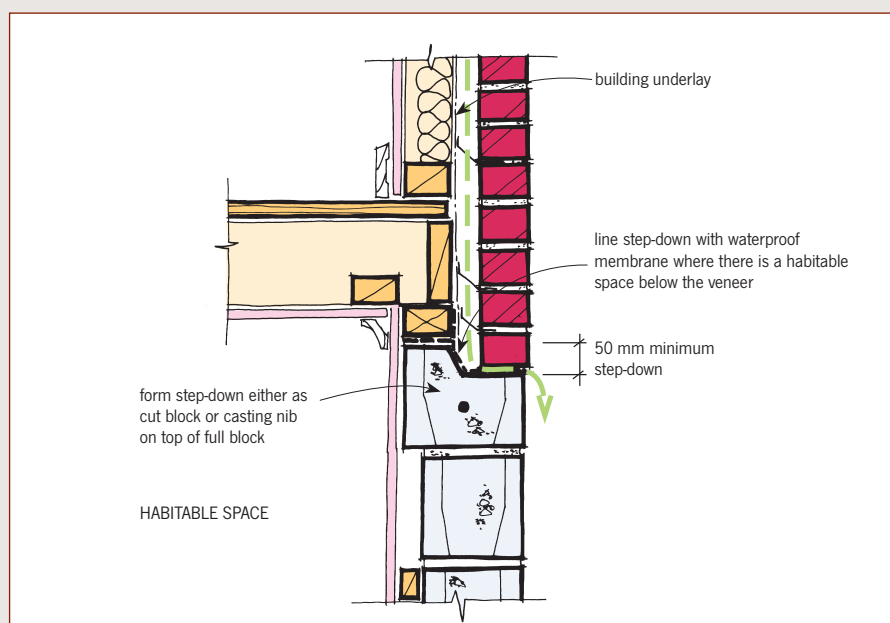
Figure 3: Correct construction details for masonry veneer on a blocked wall with a habitable space below.

A step-down is always required at the base of any masonry veneer wall, whether it starts at the ground or on the first floor (see Figure 3).

Care must also be taken to ensure that all mortar and debris is removed from the cavity so the drainage channel remains clear. ■
