# STRENGTHENING PILED FOUNDATIONS

**The recent earthquake in Canterbury was a wake-up call for the rest of the country. Owners of pre-1978 houses with piled foundations should be asking themselves if their foundations need checking and upgrading.**

By Trevor Pringle, BRANZ Principal Writer

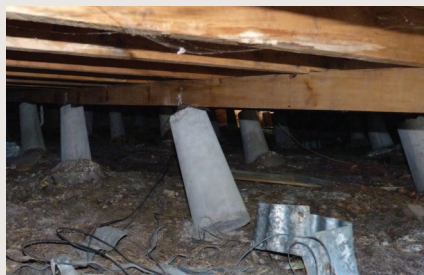
**W**hile houses on slabs in Christchurch suffered badly from liquefaction and attracted much attention, piled foundations were also not immune (see Figure 1). As in previous earthquakes, piled foundations and their connections were vulnerable to shaking damage.

Figure 1: Piled foundations that moved during the Darfield earthquake.

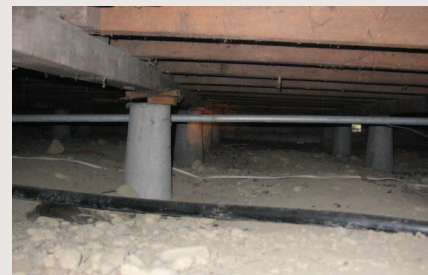
Figure 2: Many piles are not connected to the floor framing.

A straightforward upgrade option that should be considered first for existing piled foundations in houses built before 1978 is to provide adequate bearer connections to all piles. Many existing pile connections are badly corroded, and many piles are simply disconnected from the floor framing (see Figure 2).

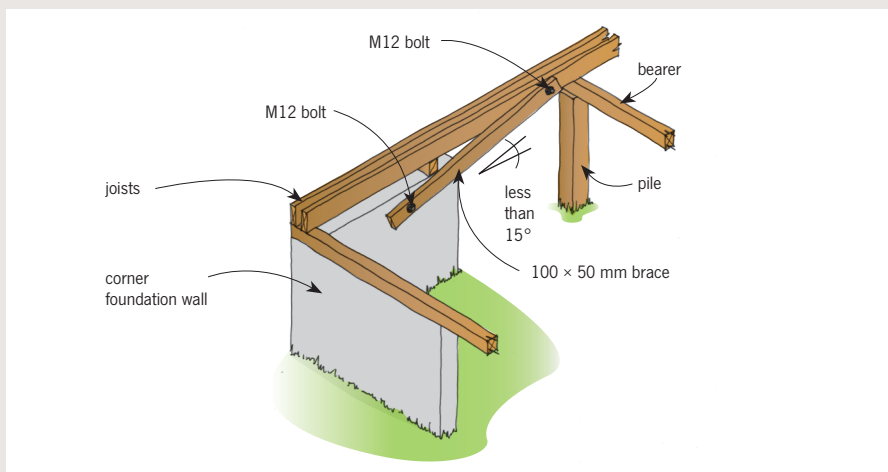
Figure 3: Corner wall foundation remedial details.

- ensure all braced piles and anchor piles have the correct 12 kN connections to bearers or joists
- add 100 × 50 mm timber braces fixed to existing piles and foundation walls or to piles and joists/bearers (see Figure 3)

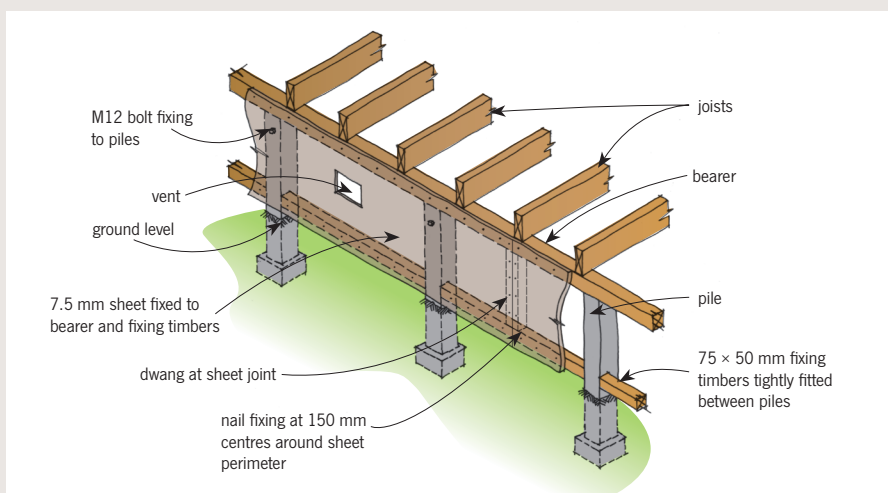
Figure 4: Bracing a piled house with sheet material. This can also be used for jack studs, probably more easily than the option below.

- fixing plywood sheet bracing around the perimeter, which may be attached to the piles directly (see Figure 4) or to the jack stud framing if on a sloping site – this can be quite tricky and may require the services of a consulting engineer

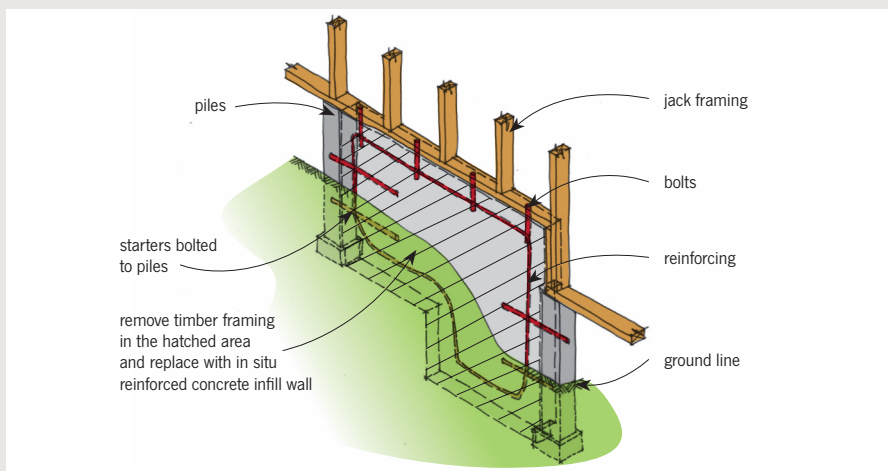
Figure 5: Jack studs on piles remedial work.

- construct a number of concrete walls between two existing piles, with starter bars fixed into the piles – to be effective, the length/height ratio of these walls should be greater than 1.5 (see Figure 5)
