# REPAIRING EARTHQUAKE DAMAGED WALL LININGS

**Many Canterbury houses have lost stiffness and strength following the earthquakes. Repairs to gypsum plasterboard linings need to restore this to prevent future small events repeating the cracking and damage.**

By **Richard Hunt and Hans Gerlich**, Engineers, Winstone Wallboards Ltd

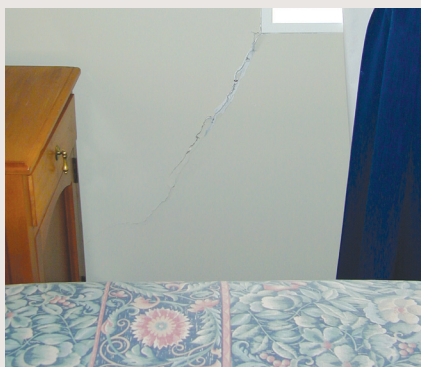
Diagonal crack in lining, which appeared at the corner of the window after the earthquakes.

Cracks within the field of the lining usually extend diagonally from the corners of openings such as doors and windows. Cracked sheets must be replaced or overlaid with a new lining.

Ensure the building has returned to square. If not, this needs to be addressed before repairing wall linings.

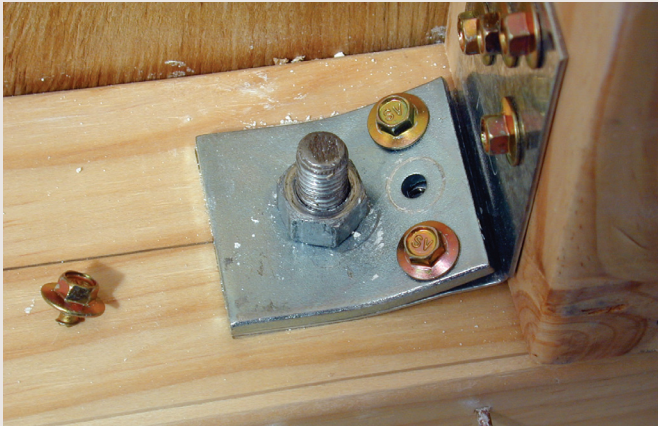
Damage to framing and panel hold-down connections is often not apparent, although damage to other elements, such as doors or windows, can indicate wider damage. Skirting boards will need to be removed to inspect damage around fasteners attaching linings to the bottom plate. Further investigation is necessary if signs of significant movement are detected. Damaged framing and panel hold-down connections must be repaired.

Damage to panel hold-down during laboratory testing.

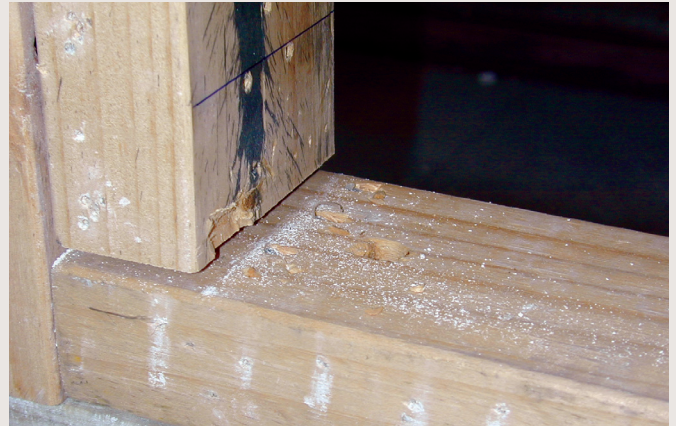
Movement may have lifted bottom plates and compromised connections. Sometimes, walls have returned to their original position, but stiffness will have been lost.

Damage to stud lift during laboratory testing.
