# UNREINFORCED CLAY BRICK MASONRY BUILDINGS

**Unreinforced masonry buildings are an important part of New Zealand's heritage architecture. A survey of the damage to these buildings following the 22 February 2011 earthquake highlighted the importance of seismic retrofitting.**

By Dmytro Dizhur and Jason Ingham, University of Auckland, and Lisa Moon and Mike Griffith, University of Adelaide

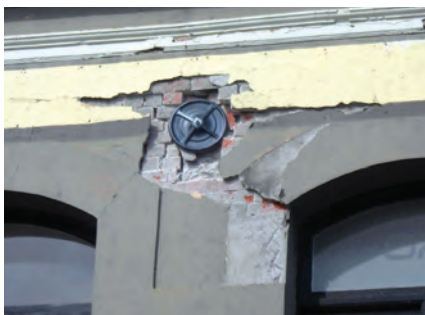
Punching shear failure was by far the most common failure type, with bricks or mortar around the anchor failing (see Figure 1). In some cases, whole bricks or sections of masonry remained attached to the anchor. Successful anchor performance did not necessarily prevent out-of-plane wall failure where there was one or two-way bending (see Figure 2).

Figure 1: Punching shear failure of roof rafter anchor plates. This type of damage was widespread.

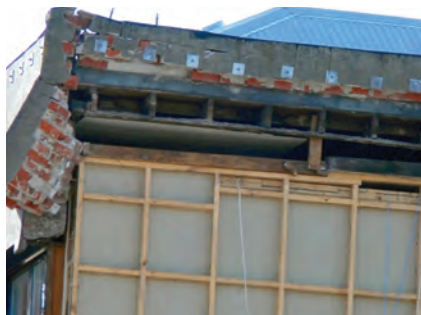
Figure 2: Row of successful wall-diaphragm anchors, despite the wall failure beneath.

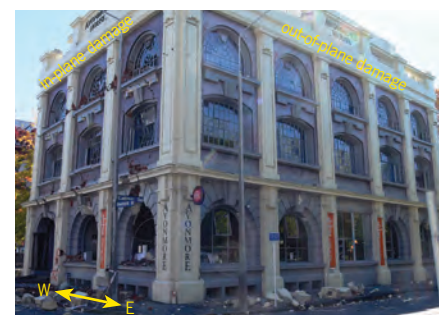
In a large number of cases in the Christchurch central business district (CBD), in-plane damage was on the north and south-facing walls, while out-of-plane damage was on the east and west walls. This indicates shaking in

the CBD was predominantly east–west (see Figure 3).

Figure 3: Looking at the southeast corner of this building, the in-plane shear cracking is only visible on the south face indicating the predominant shaking was east–west.

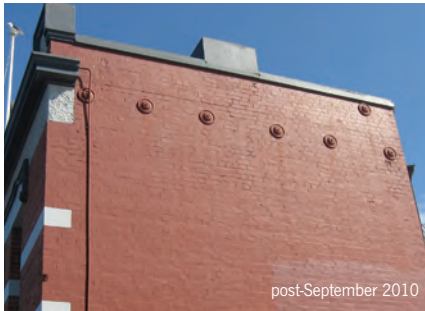
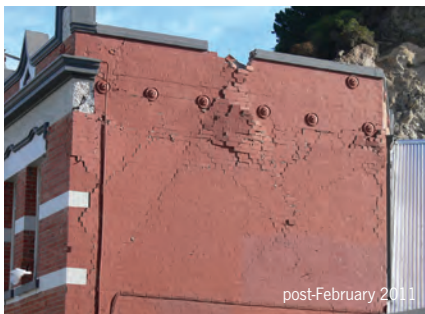
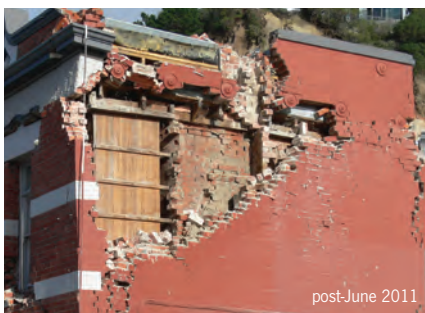
The higher seismic forces generated by the 22 February 2011 earthquake caused greater and more widespread damage to Christchurch's URM building stock than the 4 September 2010 earthquake. Building damage also got worse with the continuing earthquakes and aftershocks (see Figure 4).

Figure 4: Sequence of damage to a wall following the series of earthquake events.

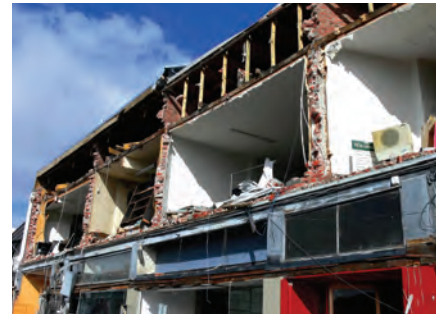
Out-of-plane wall failures were common following the 22 February 2011 aftershock, with many 2-storey buildings losing their entire front façades or upper storey walls (see Figure 5).

Figure 5: Out-of-plane failure of second storey parapet and façade.

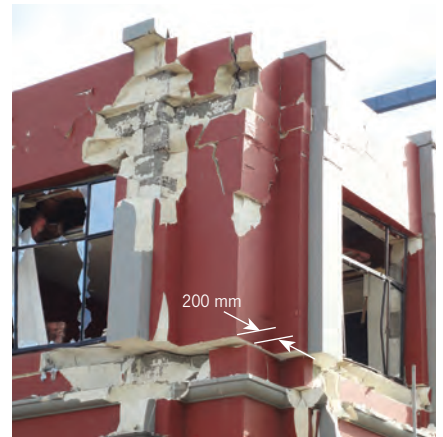
- diagonal shear cracking in piers, spandrels and walls
- shear sliding on mortar or between storeys (see Figure 6)
- in-plane rocking of piers and toe crushing.

Figure 6: The corner detail shows this upper storey has slid by 200 mm.

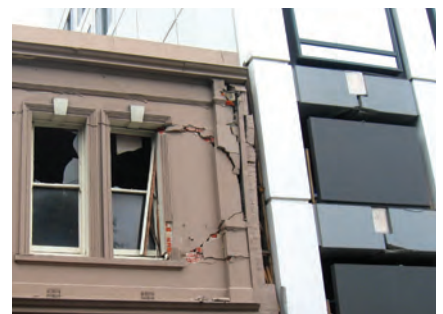
Pounding was commonly seen in closely spaced buildings in the CBD. In many cases, pounding appears to have been the loading condition principally responsible for in-plane wall failures (see Figure 7).

Figure 7: Pounding between two buildings causing diagonal shear cracking in URM building.

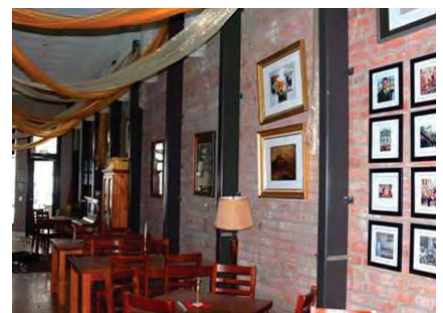
Figure 8: Steel strong-backs provide out-of-plane support for URM walls.

- steel strong-backs, which help prevent out-of-plane failure of URM walls (see Figure 8)
- steel moment frames, which increase the lateral capacity of a building (see Figure 9) →

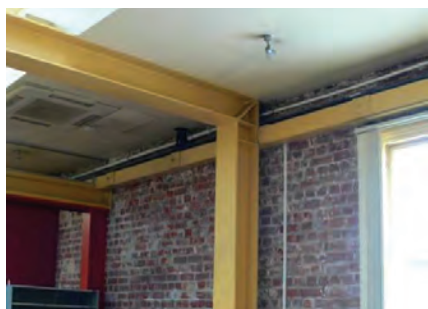
Figure 9: Internal view of steel moment frame.

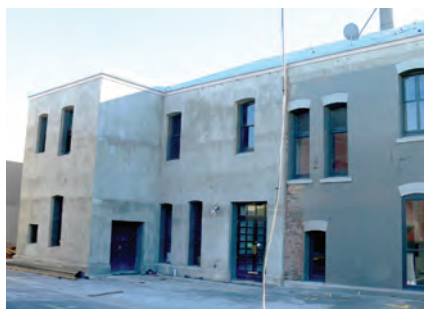
Figure 10: Retrofit with shotcrete on the rear of a building.

■ application of shotcrete, which increases the in-plane and out-of-plane strength of the walls (see Figure 10).

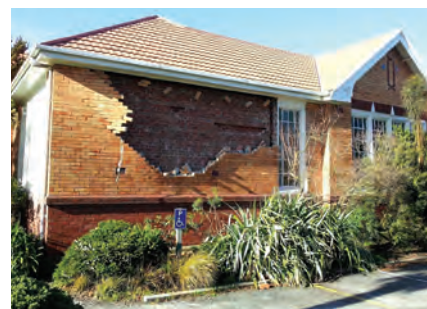
The veneer of the building in Figure 11 was retrofitted by inserting high-strength twisted stainless steel rods to tie the veneer to the main walls. In the aftershock on 22 February 2011, these rods showed signs of movement, with the rod cover being pushed out or becoming completely dislodged, suggesting differential movement between the leaves on either side of the cavity. The outer leaf of the wall collapsed during the 13 June 2011 earthquake.

Figure 11: Although this URM had been retrofitted with high-strength twisted stainless steel ties, it failed during the 13 June 2011 earthquake.
