Designing houses with unevenly distributed bracing

While the bracing requirements in NZS 3604:2011 *Timber-framed buildings* suit most buildings, the distribution rules of clause 5.4.7 are too lenient for some complex designs. During earthquakes, some Building Code-compliant buildings may move or flex, causing extensive damage. BRANZ research found which buildings are affected and suggests changes.

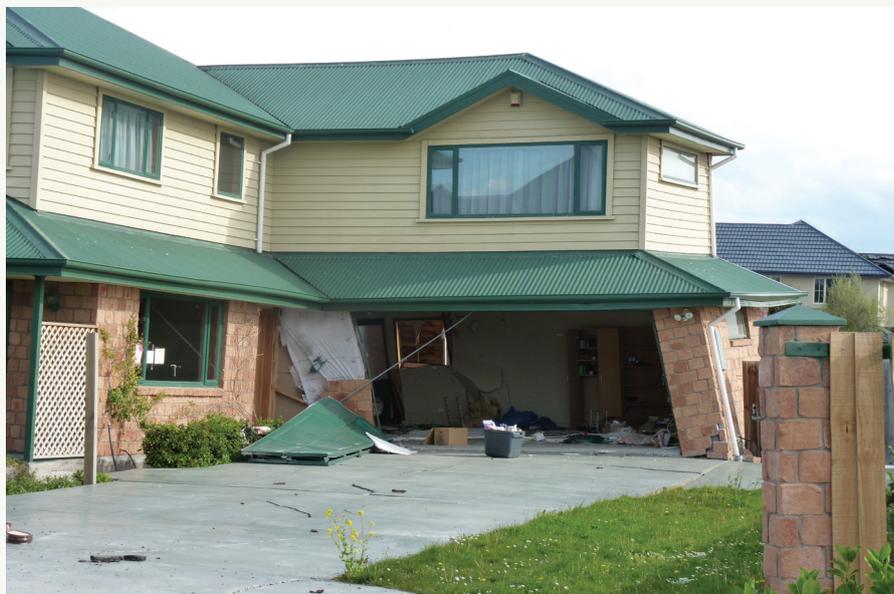
Extensive damage to a light timber-framed house following the Canterbury earthquakes.

which often have irregular bracing distributions, generally experienced the most damage, even though their designs were Code-compliant. The damage to some of these houses was so severe they were uneconomical to repair.

Tightening the current limits for irregularities in bracing arrangements in NZS 3604:2011 is needed to achieve more-resilient housing stock.

the perimeter walls by 50% could reduce lateral movement by about 40% and would keep the overall movement of buildings during earthquakes within levels that won't cause as much damage.
