CORROSION OF FASTENERS

Results from BRANZ's 3-year field exposure test on the performance of typical fasteners in timbers treated with waterborne copper-containing preservatives show stainless steel to be best for long-term durability.

By Zhengwei Li, BRANZ Corrosion Scientist

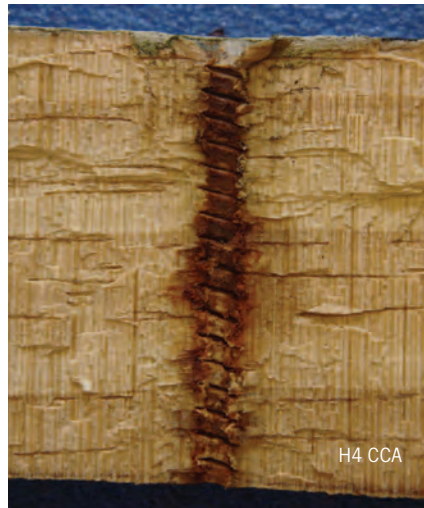
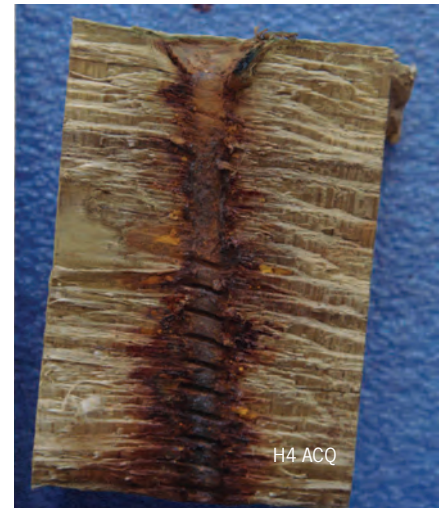
Figure 1: Iron stain formed by corrosion of zinc-coated screws in H4 CCA and H4 ACQ treated timbers exposed at Judgeford for 3 years.

The more severe corrosion in CuAz and ACQ treated timbers also resulted in heavy iron stain on the surrounding timber after only 3 years (see Figure 1). This made it difficult to retrieve fasteners, particularly screws. With longer exposure, the iron and hydroxyl ions released from the corrosion chemically attack the cellulose components of the timber and cause loss of strength and structural integrity of the joint – a phenomenon called 'nail sickness'.

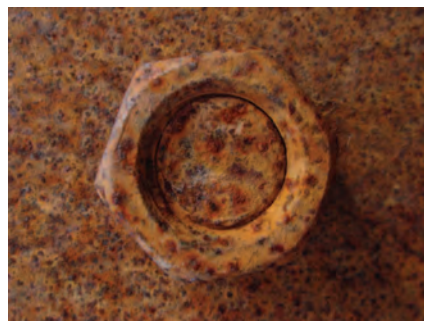
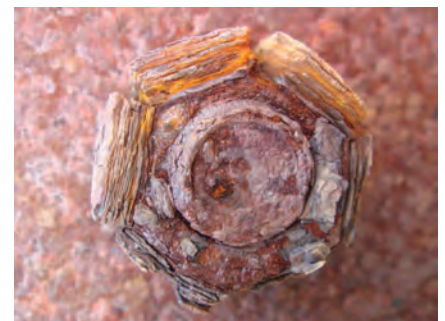
Figure 2: Mild steel nuts exposed at Judgeford (left) and Oteranga Bay (right) for 3 years.

Atmospheric corrosivity tests showed that Oteranga Bay is severely marine-influenced, whereas Judgeford lies in a rural region of average corrosivity. The influence of the macro-environment on the corrosion process can be easily seen by comparing the corrosion rates and surface morphologies of the fasteners embedded into the timbers exposed at these two sites for 3 years (see Figure 2).

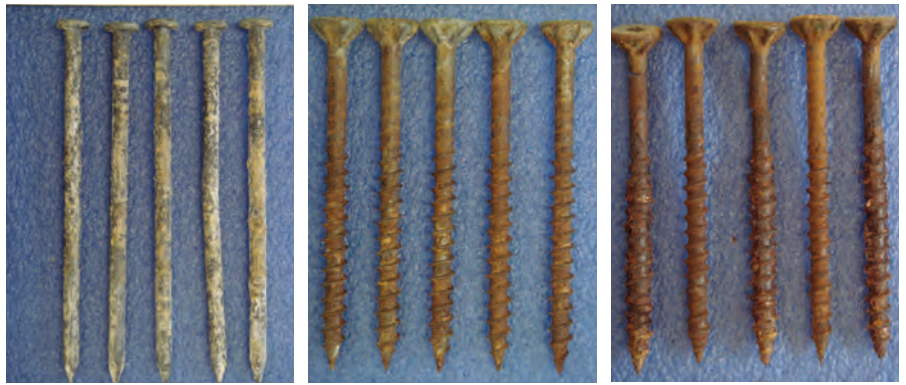
Figure 3: Fasteners removed from treated timbers exposed at Judgeford for 3 years – galvanized nails in H4 CCA (left), zinc-coated screws embedded in H4 CCA (middle) and H4 ACQ (right).

After 3 years' exposure at either Judgeford or Oteranga Bay, almost all zinc-coated screws were heavily rusted. Little zinc coating was found on the smooth shaft section below the head of the screws embedded into the untreated or CCA treated timbers. No coating remained on their spiral sections (see Figure 3) where

numerous pits of diverse morphologies were easily seen. In most cases, part of the spiral burr was corroded away.

The heavy corrosive attack on the screws was related to the nature of the zinc coatings. The screws were mechanically plated, rather than hot-dip galvanized like the nails tested. Zinc coatings formed by mechanical plating normally have a higher porosity and a lower bonding strength at the coating-substrate interface (see *Build* 117 April/May 2010, pages 34–35).

A thick and uniform coating is difficult to achieve on the spiral section, which has sharp edges and irregular surfaces. This makes these areas more vulnerable to corrosion. The driving-in process always damages the coating integrity to some extent and introduces more physical defects. As a result, zinc-coated screws are less corrosion resistant than hot-dip galvanized nails, particularly when embedded into timbers treated with copper-bearing preservatives and exposed to the atmosphere. →

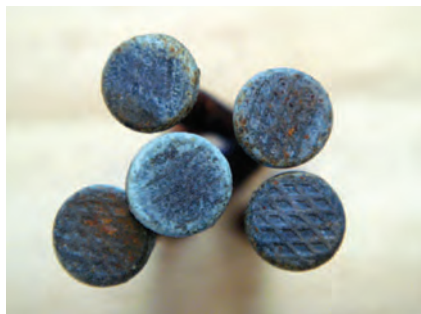
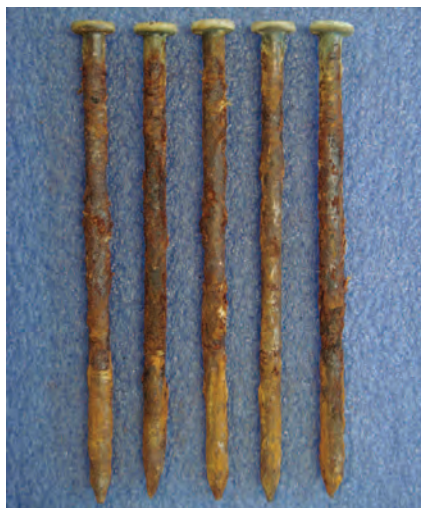
Figure 4: Galvanized steel nails embedded into H4 ACQ treated timbers exposed at Judgeford for 3 years. The condition of the zinc coatings on the head and the body were significantly different.

In the field exposure tests, it was frequently observed that the head of a zinc-coated fastener was still in good condition, while its body was covered with heavy iron-rich rust. This was particularly true for nails exposed at the Judgeford site, the more benign climate (see Figure 4).

This phenomenon is a direct result of the difference in aggressivity of the atmosphere and the micro-environment inside the treated timber. The latter generally attacks the metal at a greater rate due to galvanic corrosion, with the additional influence of oxidisers introduced from the preservation treatment. Timbers treated with CuAz and ACQ have a higher retention of copper ions, leading to faster degradation of metals in contact with them.

Galvanised nails and screws in ACQ and CuAz treated timbers may not meet the 50-year durability requirement for structural connections where the timber will get wet, such as outside or in contact with the ground or concrete.

BRANZ recommends austenitic stainless steel (for example, AISI 304 and 316) or silicon bronze in these situations.

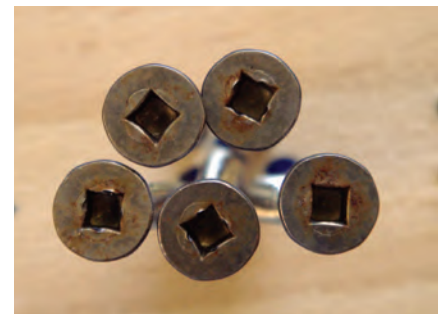
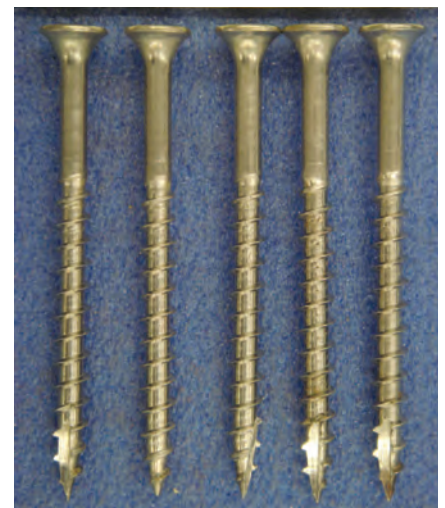
Figure 5: Stainless steel screws embedded into H4 ACQ treated timbers exposed at Oteranga Bay for 3 years. Limited rust was formed only on the head top.

Limited rust on the top surfaces of their heads was more frequently observed on the fasteners exposed at Oteranga Bay (see Figure 5). However, a comparison between the conditions of the rust formed after 1, 2 and 3 years indicated that this localised corrosion was progressing extremely slowly and the extent of material deterioration was not affecting the performance of the fasteners or the timber-metal assemblies.

This head deterioration was probably the result of local passivation breakdown from the hammer-in process and/or ferrous contamination transferred from the hammer head. When exposed to the marine environment, this localised corrosion can be intensified by airborne chloride ions.
