# ON THE GROUND IN CHRISTCHURCH

The 6.3 magnitude earthquake that struck Christchurch on 22 February 2011 and the many aftershocks have been an enormous test of the performance of buildings. BRANZ structural engineers provide some initial thoughts on how houses performed.

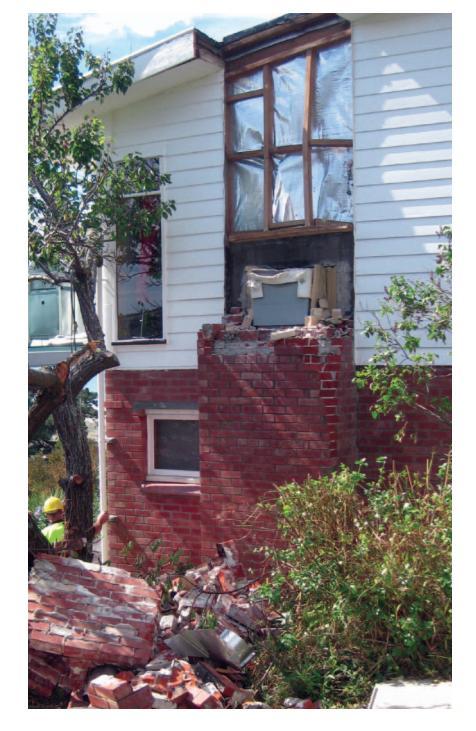
Unreinforced clay brick chimney collapse, while timber-framed house construction remains intact.

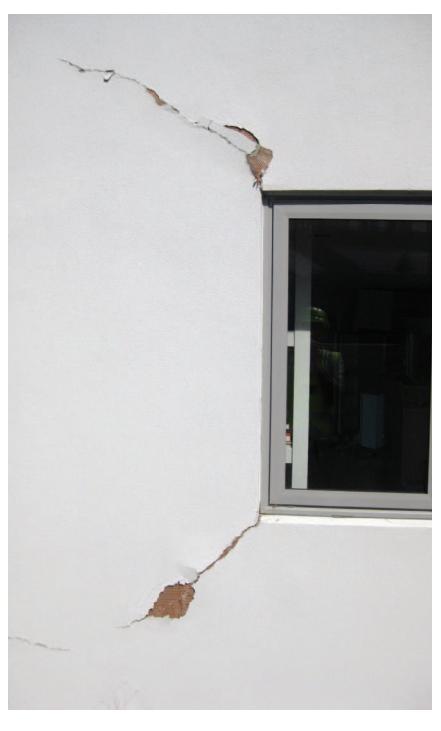
Damage to monolithic cladding

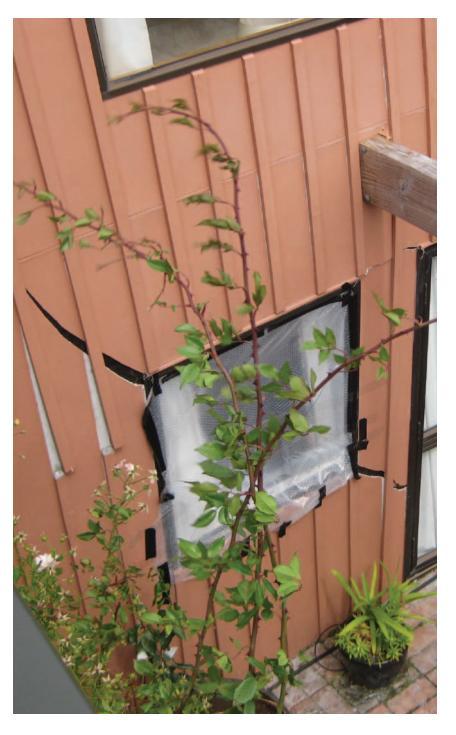
Cracking of cement-based sheets.

Fibre-cement sheet is a common cladding, and because it is generically a brittle material by nature, examples of sheet failures were observed.

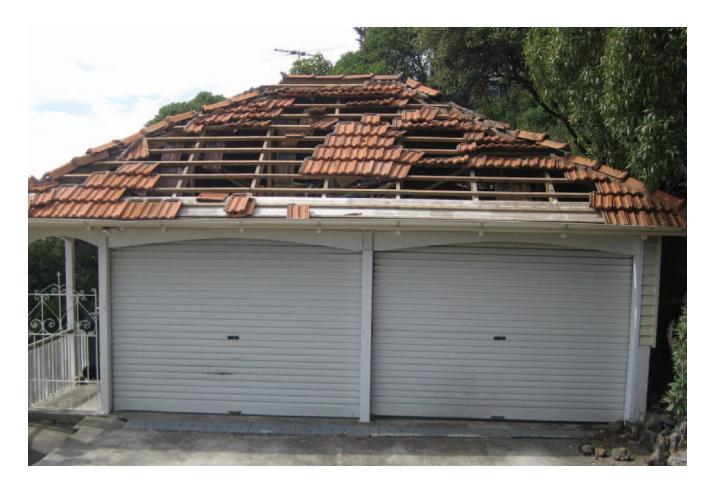
Clay roof tiles were nearly always dislodged to varying degrees, with many roofs significantly damaged. In one house (see below), the tile roof is pretty well intact other than at a party wall where the inertia of the heavy

Significant damage where tiles were not adequately tied to the battens. Some extra tile removal has also been undertaken.

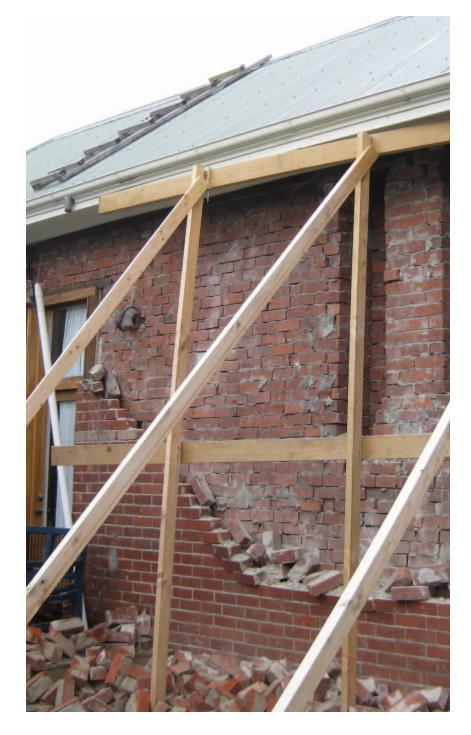
There was extremely variable performance where bricks were used. At one end of the spectrum, unreinforced loadbearing masonry such as double-brick construction performed generally very poorly with, not unexpectedly, widespread failures occurring.

Collapse of double-skin unreinforced clay brick wall.

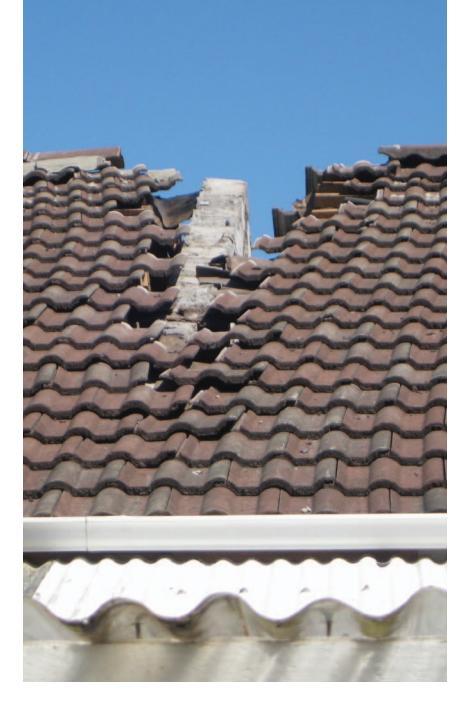
tile roofs on either side overcame the roof space lateral bracing capacity and fractured at this junction.

Concrete tile roof fracturing at party wall junction

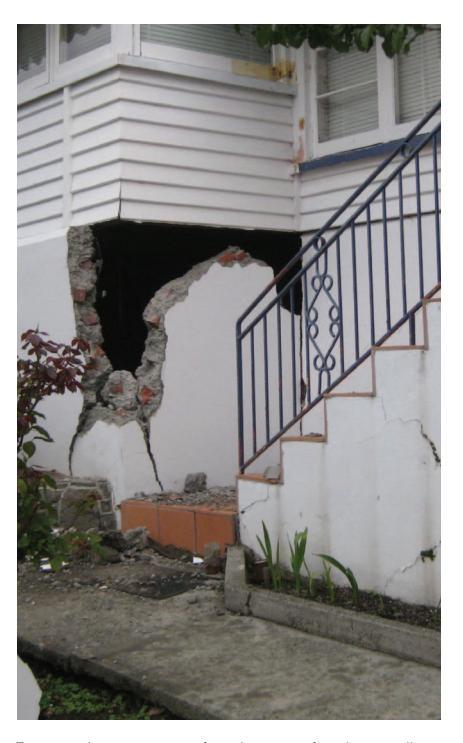
There were widespread failures of foundation walls that had little or no reinforcing steel. There were also many examples of foundation wall-to-slab failures where the connection between the wall and slab failed or where sliding of the slab occurred because there were no mechanical fixings present.

Extensive damage to unreinforced concrete foundation wall. Note the fragments of clay brick as aggregate.
