SOLID FLOORS AND FLOOR JOISTS

By Alide Elkink, Freelance Technical Writer, Wellington

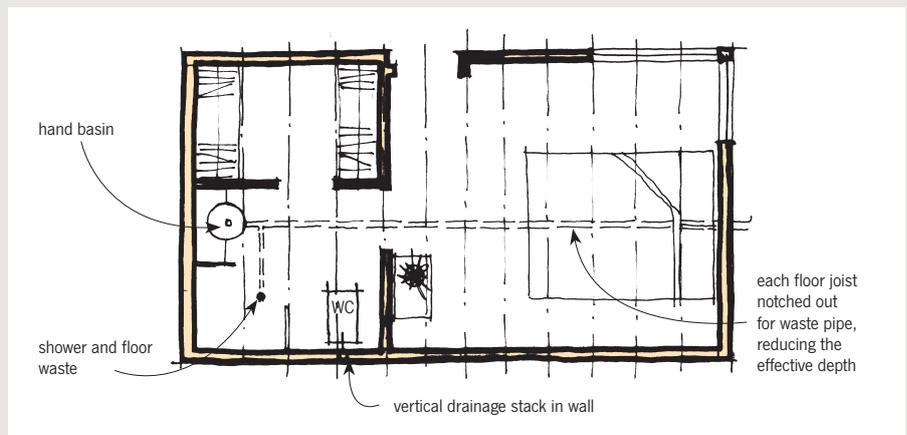
Figure 2: Weakening of the floor joists through over-cutting caused the bouncy floor.

However, further investigation of the floor structure revealed that every floor joist had a hole drilled through it at approximately midspan to accommodate the wastewater pipe that ran through the floor space perpendicular to the joists from the adjacent ensuite bathroom.

The holes reduced the effective depth of the joists to less than that permitted for their span under NZS 3604:1999.

Fixing the bouncy floor in the bedroom was a major exercise as it involved taking up the entire floor in both the bedroom and adjacent ensuite bathroom (see Figure 2). The waste pipe running through the floor space was removed and a ceiling bulkhead was created in the space below the bathroom through which the waste pipe could be routed before discharging to an existing vertical drainage stack.

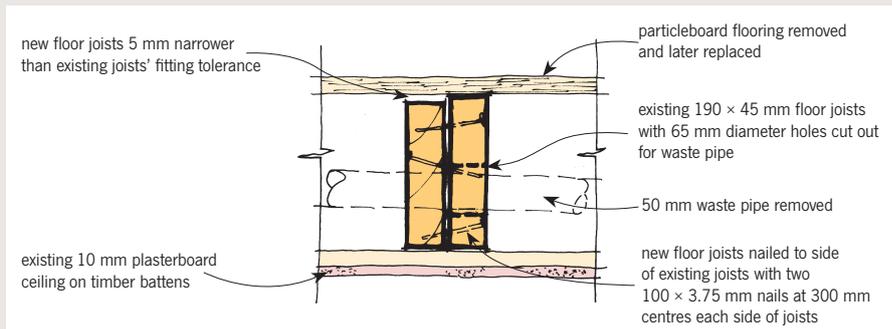
Figure 3: Strengthening floor joists.

Joists were checked for sagging and propped from below where necessary to remove any sag. All joists were then strengthened by attaching new joists, cut 5 mm narrower than the existing to allow for a fitting tolerance, to the sides of the existing joists and fixed with two 100×3.75 mm nails at 300 mm centres on each side of the joists (see Figure 3). New flooring was then installed.
