Concrete: a strong tradition

Around since the early days of New Zealand settlement, concrete is everywhere, from paths to pools, foundations to fountains.

By Nigel Isaacs, BRANZ Principal Scientist and Teaching/Research Fellow, School of Architecture, Victoria University of Wellington

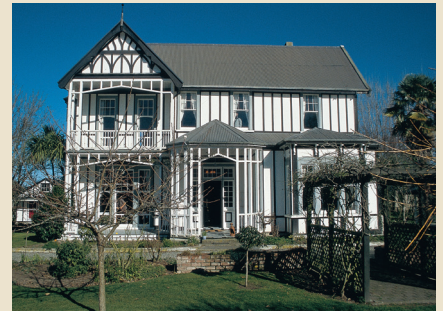
A very early example of a precast concrete slab house is Homebush, constructed in the late 1880s in Masterton.

Many concrete buildings have been built since the 1860s, but an unusual one is 'Homebush' designed by Charles Tilleard Natusch and built in the late 1880s. Natusch was known for his 'board and batten' style homes, but Homebush is constructed of precast concrete slabs fitted into wooden framing with the joints covered by timber battens. Presumably, the inspiration for this was a precast, reinforced concrete low-rise house system patented by William Lascelles in England in 1875, which was the subject of some discussion in Wellington in 1888.
