Damaging Northland storm

BRANZ was on the ground in Northland last year, examining the effects of a storm on buildings. Roofs bore the brunt of the weather, with structures on exposed terrain the most vulnerable.

BY ASIF IQBAL, BRANZ STRUCTURAL ENGINEER

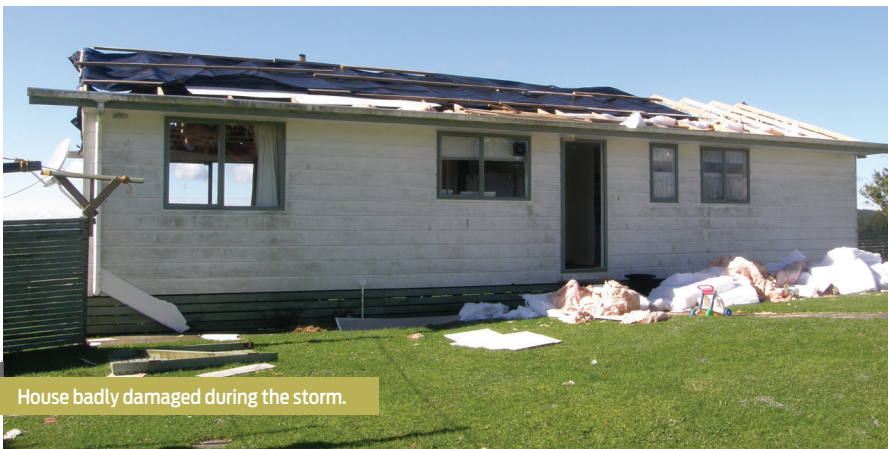
House badly damaged during the storm.
