Seismic performance of brick veneer

Brick veneer is currently popular, being used in about 44% of new houses. Historically, brick veneer houses have not performed well in earthquakes but after recent building changes, how do the modern houses stand up?

By **Stuart Thurston**, BRANZ Senior Structural Engineer

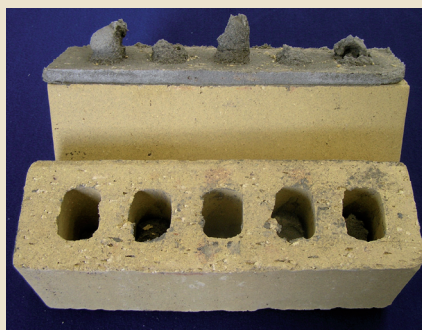
Figure 1: Clay bricks used showing mortar dowels.

The clay bricks used in the investigation had five vertical holes for the full brick depth that were partially filled with mortar (Figure 1). This formed mortar dowels that provided a mechanical connection between the individual bricks, improving resistance to earthquake forces. The concrete bricks tested did not have these holes.

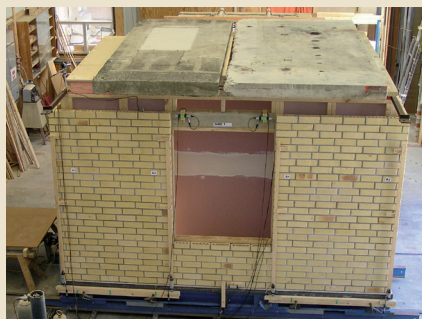
Figure 3: Building before shake table tests.

Shake table tests were also performed on another two small buildings (see Figures 3 and 4). Shake table testing simulates the speed and displacements caused by real earthquakes. A large concrete mass was attached to the roof to model the weight of a tile roof of a real house. One of the buildings used clay bricks and the other used concrete bricks.

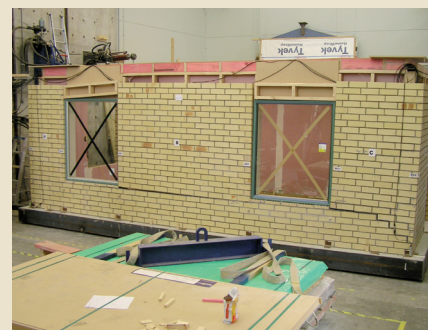
Figure 2: Clay brick veneer building after cyclic racking tests.

Slow cyclic racking tests were performed on two small, single-storey clay brick veneer buildings (see Figure 2). Cyclic racking means the building was pushed and pulled

backwards and forwards in a manner simulating a real earthquake.

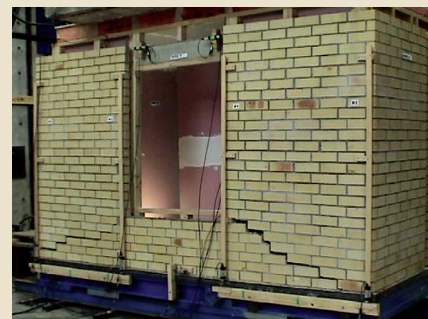
Figure 4: Building during shake table tests.

At extreme levels of shaking, more than three times the design level, the clay brick veneer remained intact (Figure 4). However, at twice the design earthquake, the concrete brick veneer began to disintegrate into separate bricks after 10 seconds of shaking (Figure 5). After a further 10 seconds at this shaking, partial collapse had occurred in some areas.

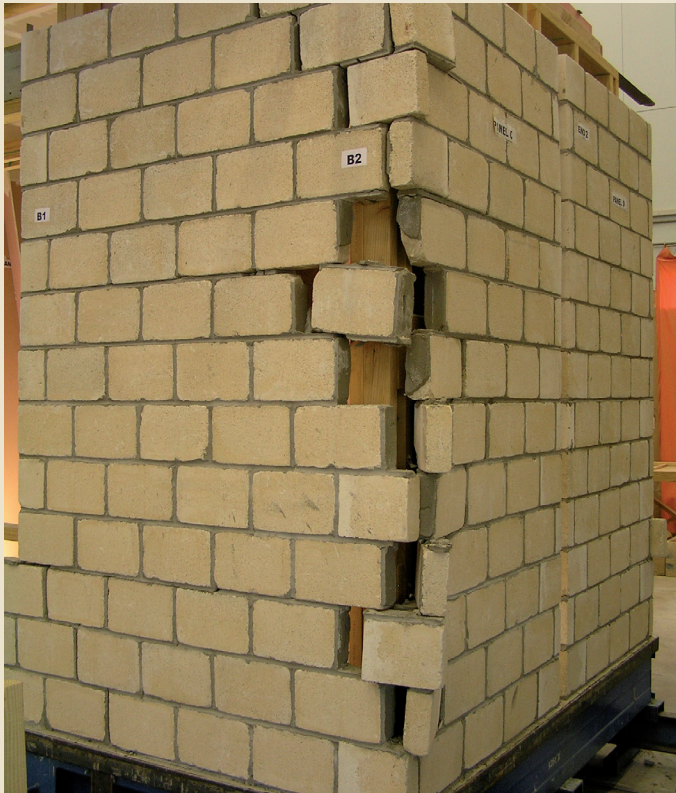
Figure 5: Damage to concrete brick veneer after *extreme* levels of shake table testing.
