HEAT PUMP ONLY AS GOOD AS ITS INSTALLATION

There has been a rapid growth in the number of heat pumps installed over recent years. Although an ongoing BRANZ study shows that many installations meet the regulations, there is still room for improvement.

By Lisa Burrough, BRANZ Energy Efficiency Scientist

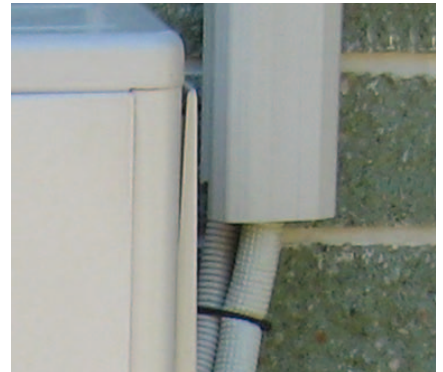
Checks of the exterior ducting, flashings and waterproofing revealed that 93% of installations met the recommendations for these areas. However, few heat pumps had sealed gaps around the pipes coming out of the ducting

(see Figure 1). The pipes mostly went straight through the external wall and then down the outside of the building.

Figure 1: No sealant in the gap at the end of the ducting.

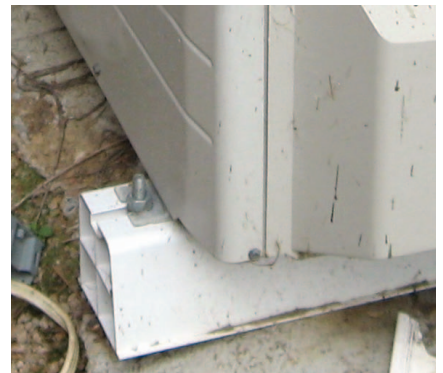
Some outdoor units (10%) were unstable. Often they had been connected to a bracket to keep the unit off the ground, but the bracket hadn't been connected to something solid, for example, concrete (see Figure 2). Although clearance of the unit from the ground wasn't part of the check, many were found to have little clearance (see Figure 3), often much less than the 100 mm recommended.

Figure 2: Unit not fixed to the ground.

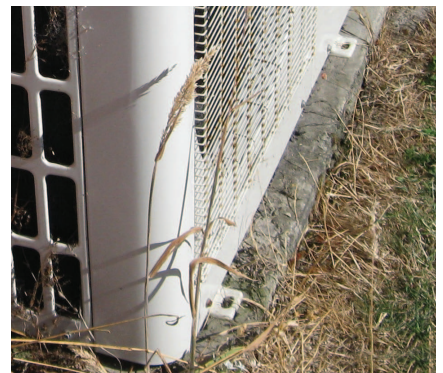
Figure 3: No clearance under the unit.

The second year installation check will investigate and record in more detail the problems highlighted so far (for example, clearance from the ground and sealing of ductwork). With the larger number in the sample, it will be possible to break down the results into heat pump age, make, in-situ performance and geographical location. Comparisons will also be made between the size of the installed heat pump and the size suggested by the heater sizer in the *EECA Good practice guide*.
