Building resilience in volcanic eruptions

A local volcanic eruption is a substantial risk to the Auckland region. Research into the impact of multiple volcanic hazards on the roofs of buildings showed that they generally deal well with volcanic ash and flying rocks landing on them.

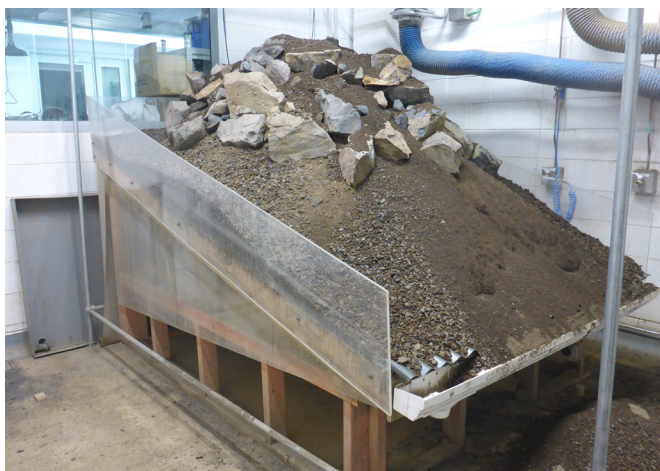
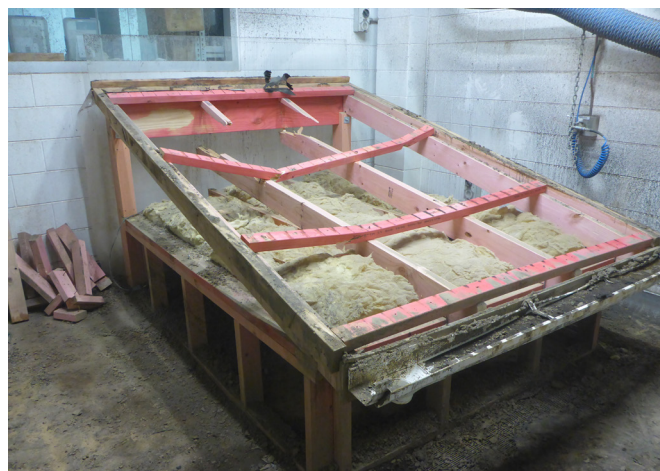
Figure 2: Tephra load during experiment (left) and the structural damage (right).

The experimental structure exceeded expectations of collapse load and endured almost 17 kPa of tephra load (Figure 2). The mechanism of collapse was failure at the ridge-rafter fixings. This is not commonly seen in worldwide post-eruption impact assessments that generally find mid-beam component failure. However, New Zealand has different component and building standards to those where post-eruption impact assessments have been conducted.
