# Full-scale structural testing of school buildings

Recent work provided valuable insights into the seismic capacity of buildings commonly used in schools nationwide. This provided a unique opportunity to test whole buildings on site to understand their performance and to test the main structural elements in the laboratory.

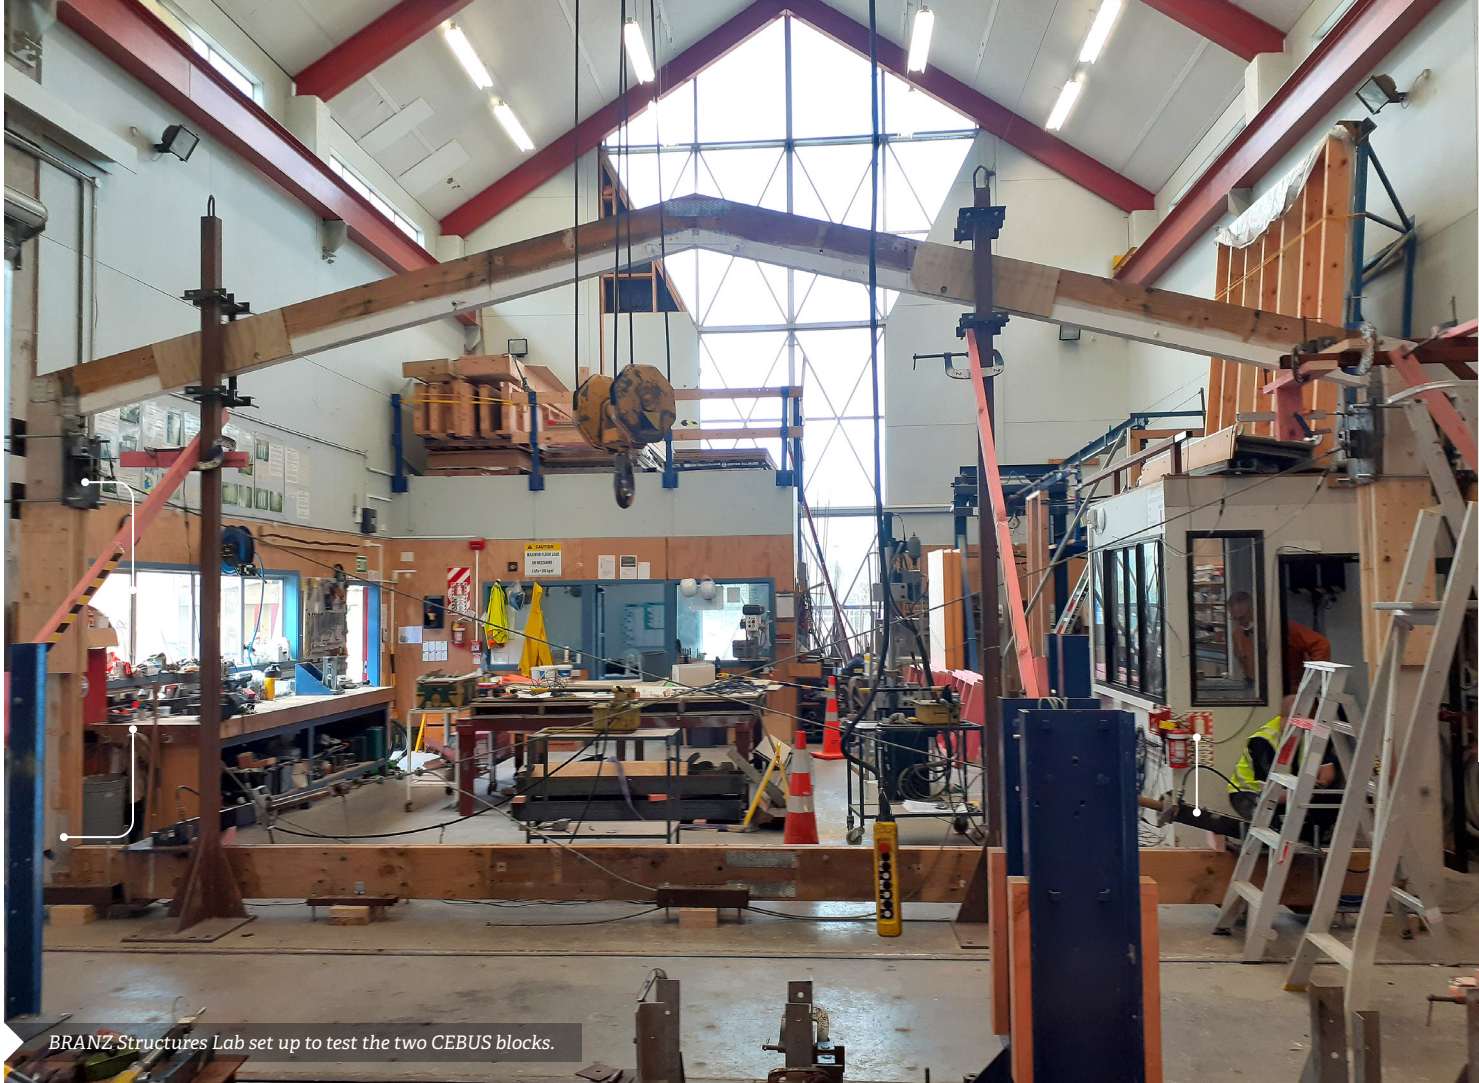
BRANZ Structures Lab set up to test the two CEBUS blocks.

strong floor to simulate the in-situ foundations and avoid uplift during testing.

Rollers were also placed on either side of the rafters to model the roof purlins and avoid transverse movements as loads were applied. Displacement measurements were recorded throughout testing and located to allow for comparisons with the on-site testing.

Block A frame testing included single cycles in both directions of 1 kN load levels, which were increased up to horizontal loads of approximately 15 kN, at which point the frame was racking significantly and considered failed.

directions, the increment was cut back to 0.5 kN due to the greater flexibility of the frame. Horizontal loads of only 5 kN were reached before testing was stopped due to large movements and the frame was considered to have failed.
