Concerns with B2 *Durability*

The guidance for using structural steel and other metals in Building Code clause B2 *Durability* is limited, and no Acceptable Solutions are offered. Perhaps there's a need for an addendum to be incorporated.

BY RAED EL SARRAF, OPUS CORROSION AND ASSET INTEGRITY CONSULTANT AND AUSTRALASIAN CORROSION ASSOCIATION NZ BRANCH PRESIDENT

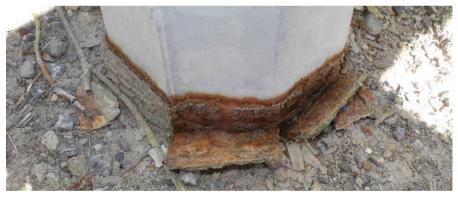
Figure 1: Ring bark corrosion on 18-year-old lighting pole. This has lost up to 40% of its original thickness.

A common poor detail with a simple solution is not applying additional protection for ground or concrete-embedded steelwork, such as columns and lighting poles. In most cases, these are hot-dip galvanized, and without protection, ring bark corrosion (see Figure 1) will occur at the ground to air interface. This often results in significant section loss and possible structural failure before the end of the intended life.

Figure 1 shows an 18-year-old lighting pole that has lost up to 40% of its original thickness. This could have been mitigated by applying an additional protective coating for the ground-embedded portions of the pole, up to 50 mm above the interface. This information is given in HERA Report R4-133 and NZ Transport Agency M26 *Specification for lighting columns*. It has been available since 2005 but is not commonly used by design engineers.

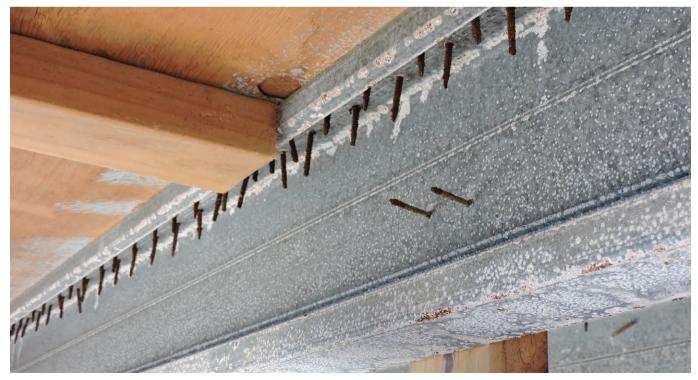
Figure 2: Roof cavity in 1990s house. Inline galvanised purlins with a heavy build-up of white and red rust indicating depletion of the original corrosion protection.

Figures 2 and 3 show the roof cavity of a late 1990s building. Access to the cavity required the removal of the building soffit. Based on B2.1.2.1(a), elements that are difficult to access or replace elements within such a cavity require a durability of not less than 50 years.

The inline galvanized purlins have a heavy build-up of white rust with signs of red rust commencing on the purlin and the holddown screws. This indicates that its original corrosion protection is completely depleted. Clearly, the required 50-year durability period for these purlin and screw elements will not be met.

Moisture levels were high in this cavity, and degradation is due to the elements being on the cold side of the building and cooling to below the dew point. Condensation has then occurred on their surface.

While removing the soffit to expose the elements, a large volume of collected condensation water was found ponding on the cladding. This, in turn, increased the period of wetness and humidity that they were exposed to.

This was not the dry internal environment the designer originally assumed. The atmospheric corrosivity in this microclimate was likely to have been closer to C3 (medium) than the assumed C1 (very low) corrosivity category. *Many simple design solutions*
