SOLID FLOORS AND FLOOR JOISTS

By Alide Elkink, Freelance Technical Writer, Wellington

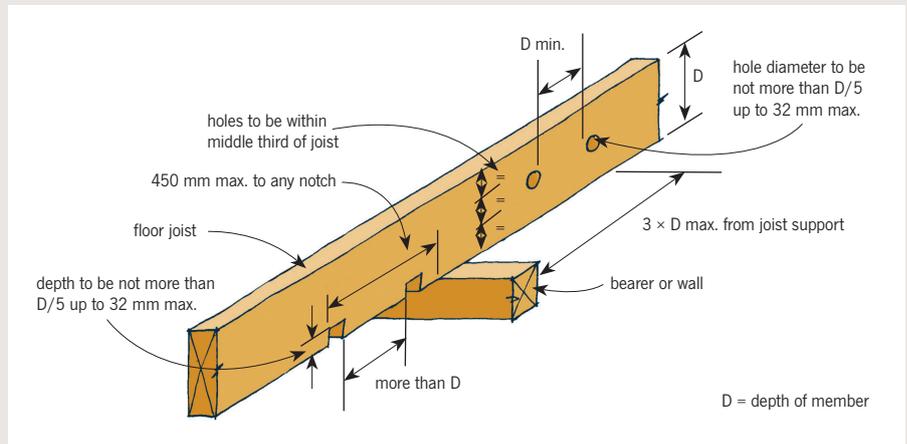
Clause 7.1.7 and Figure 7.8 of NZS 3604:1999 put limitations on the size, location and number of holes and notches that may be cut into floor joists (see Figure 1).

An exception to the limitation of paragraph 7.1.7 is permitted when notches do not reduce the effective depth of the joists. Paragraph 7.1.7.4 states that no holes or notches are permitted in cantilevered joists, except as permitted in paragraph 7.1.5.2, which requires that the joist depth at any notch, step or hole occurring within two-thirds of the cantilever support must be at least the depth required by Table 7.2.

Figure 1: Cuts in floor joists in accordance with NZS 3604:1999.

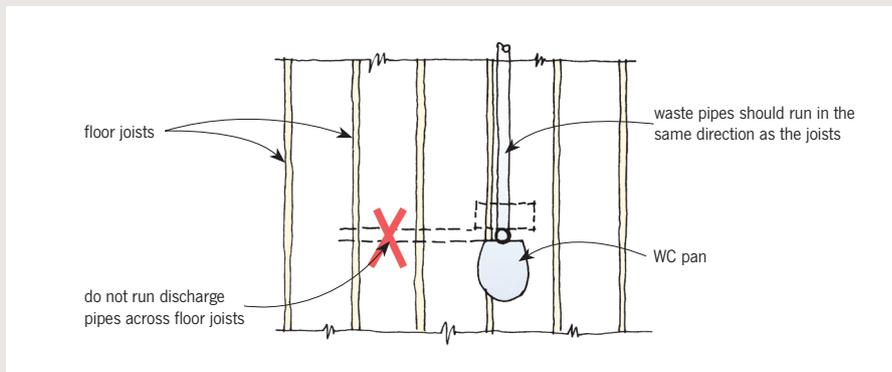
The lesson from this is that services should always be considered at the design stage of a building project. Although plumbing and drainage pipes can be installed underneath the floor joists of a ground level suspended timber floor, waste pipes under the first floor need to be carefully integrated within the building structure. Ideally they should be run parallel with the joists to avoid the need for drilling and notching (see Figure 4). To do this, there must be sufficient depth between the floor and ceiling to accommodate:

Figure 4: Discharge within floor depths.

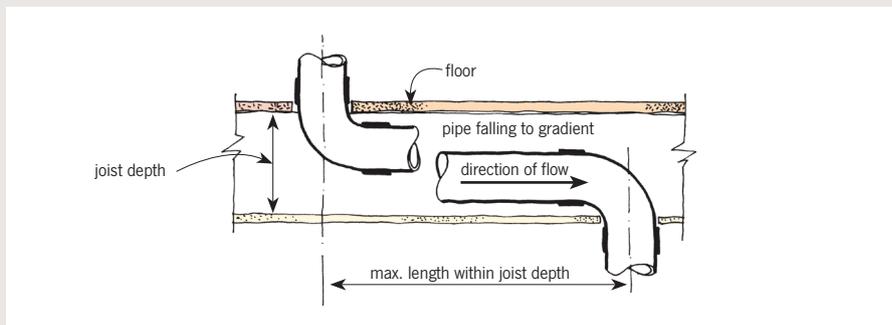
Figure 5 shows how pipe diameters, gradients and bends should be considered and incorporated. Holes must not be drilled through joists unless they are specifically designed and approved. ❖

Figure 5: Allowance for fall within a floor.

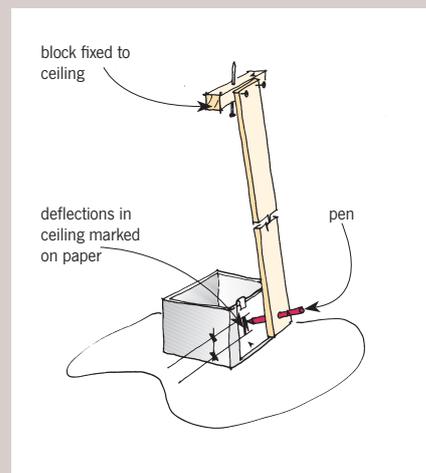
The deflection of a bouncy floor can easily be measured by fixing a batten to the ceiling below the floor at the greatest span of the floor joists. Attach a marking pen at the other end (see Figure 6). Paper or a vertical marking surface is placed where the marking pen hangs down. As the floor and ceiling above deflects, the range of vertical movement will be transferred onto the paper or marking surface. ❖

Figure 6: Measuring floor deflections.
