# PROTECT THOSE WEATHERBOARDS

**A *Build* reader recently asked if H3.1 treatment for timber cladding is sufficient to protect against rot. It is, but only if primed before installation, painted and regularly maintained.**

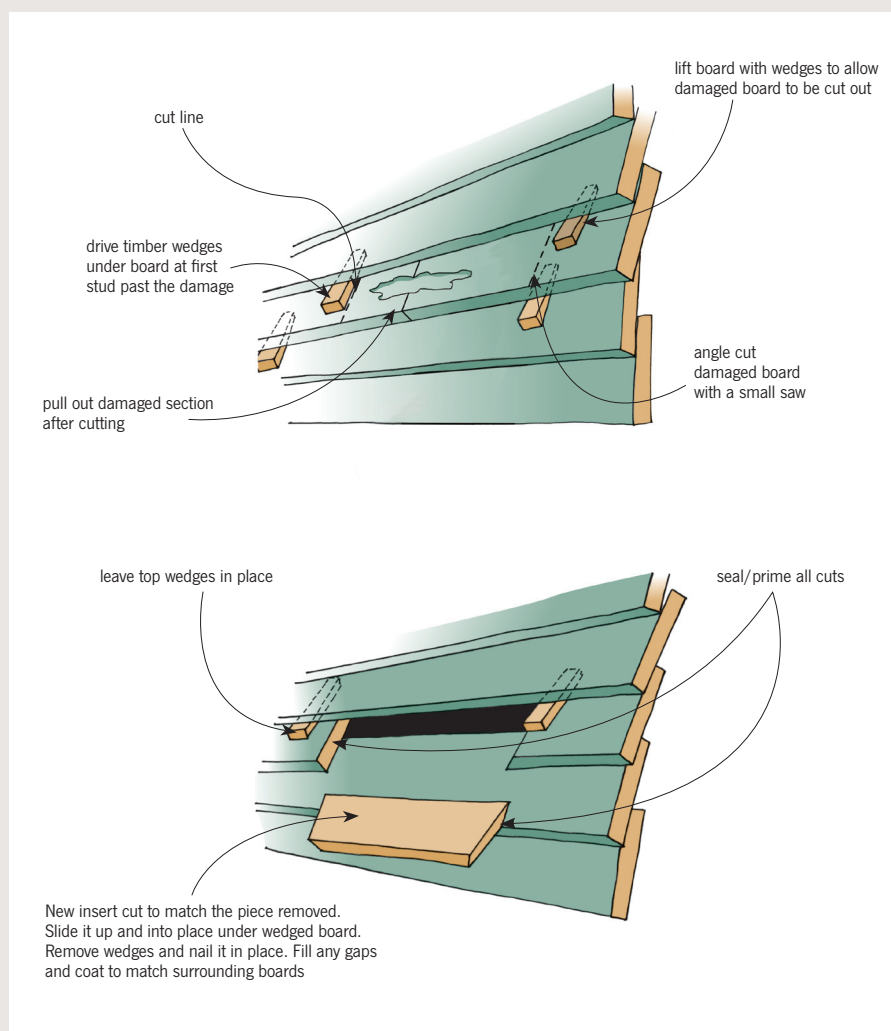
Figure 1: Repairing a damaged weatherboard.

- cut out the section to nearest studs (at least 600 mm in both directions from rot) and slant cut edges (see Figure 1)

- check building wrap and framing are sound
- treat cut ends of existing timber with a paint-on preservative
- prime replacement timber and any existing timber that has been exposed
- fit insert of correctly treated timber, nail edges of existing and new boards – one nail per board per stud
- increase weather protection by butting joints and covering mitred corners with galvanised steel, stainless steel or copper soakers or timber cover boards (the same level of priming and painting is still needed)
- apply white or a light colour paint to minimise movement in the timber due to temperature changes.
