Corrosion rates in vented roof cavities

BRANZ research has provided reassuring results for those wanting to add passive ventilation in roof cavities to counter condensation. Corrosion of metal fixings inside the roof space remains low, even in extreme marine environments.

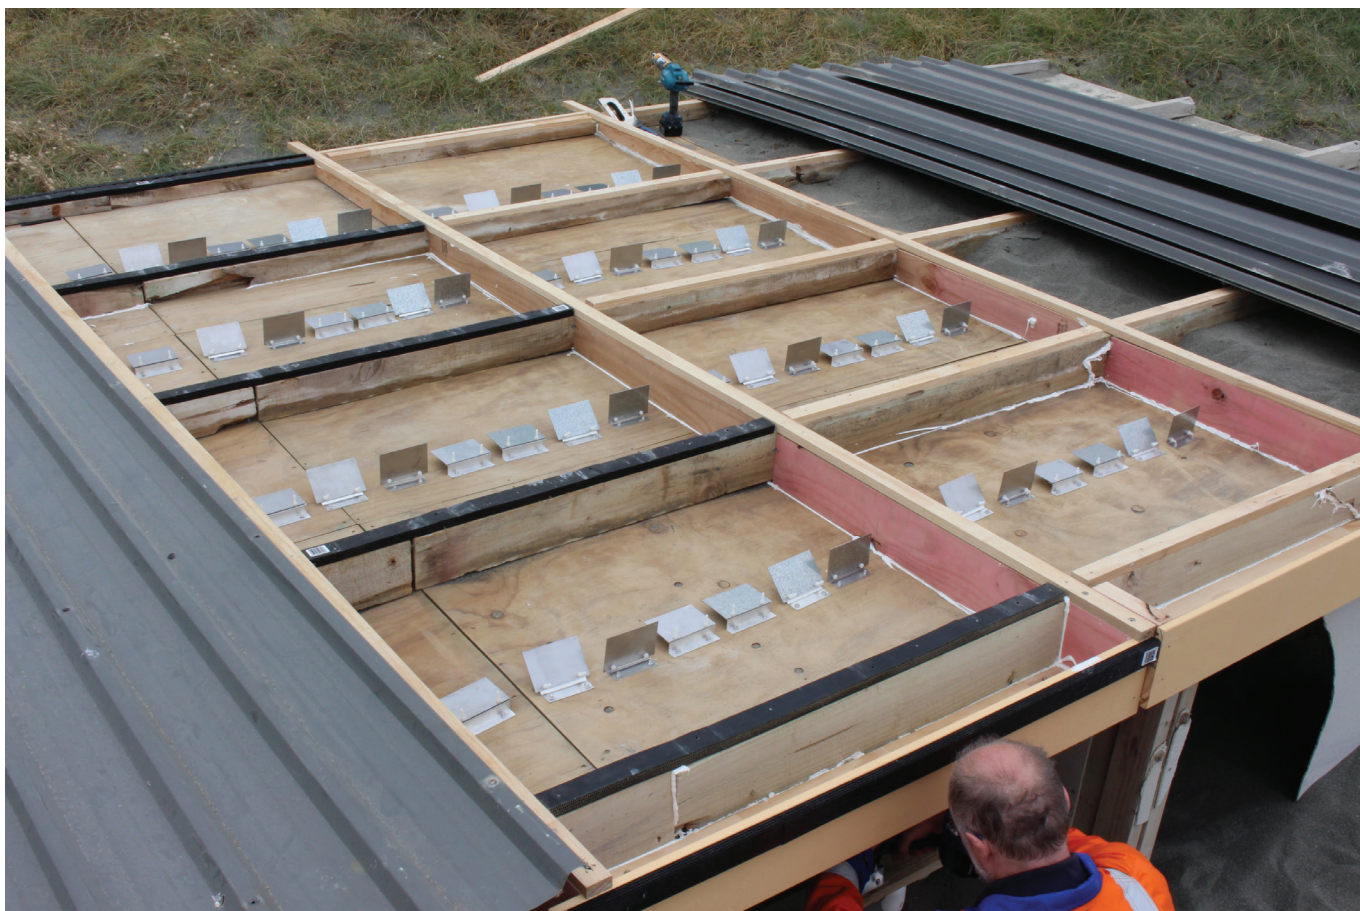
Figure 1: Mild steel and galvanised samples were mounted inside the vented and unvented roof areas at different angles – vertically, horizontally and at 45° to vertical.

BRANZ has a test structure near the sea that was modified for this experiment. The dwelling has two similar-sized roof cavities - one vented and one unvented. Mild steel and galvanised samples were mounted inside the vented and unvented roof areas at different angles - vertically, horizontally and at 45° to vertical (see Figure 1).

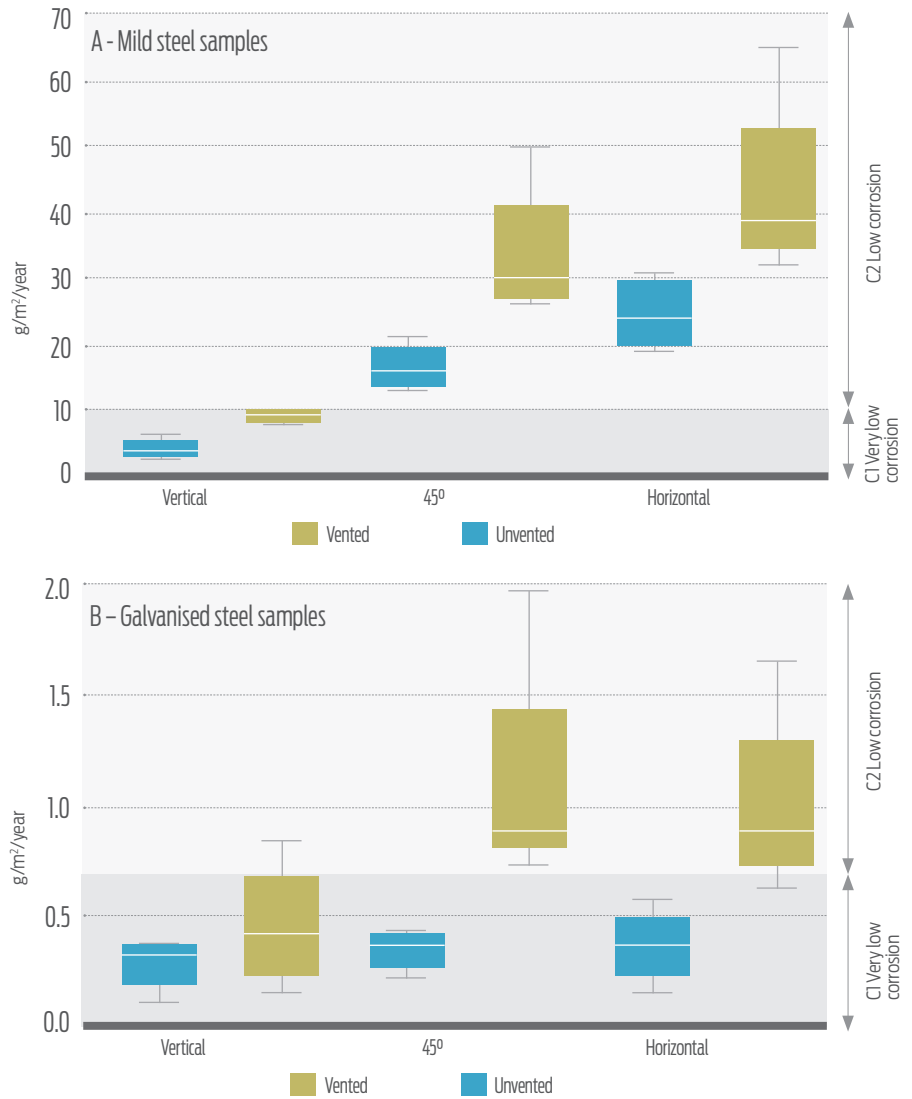
Figure 3: Measured corrosion of all mild steel and galvanised samples in the vented and unvented cavities of the roof test structure. Note: The scale on the two charts are different.

The corrosion rates inside the roof cavity were found to be significantly lower. Figure 3 shows the results for the galvanised and mild steel samples in the vented and unvented cavities.

We further distinguish between samples mounted vertically, horizontally and at a 45° angle. The results are given in the form of so-called box whisker plots. The white horizontal bar indicates the median value, and the upper and lower limits of the box represent the 75% and 25% quartiles, while the whiskers give upper and lower extreme values.

From the plots, we can conclude that the first-year corrosion rates were higher in the vented part of the roof space than for their counterparts in the unvented cavity for both types of steel, regardless of the orientation the sample was mounted at. This is consistent with expectations.

However, the corrosion rates for all samples placed inside the test structure fall into the C1 Very low and C2 Low ranges of corrosion (see Table 1). Given the extreme conditions at this site, these baseline results are reassuring even though not all aggravating factors could be explored. A higher time of wetness and localised salt deposits may still lead to higher corrosion rates in some places. ◀
