Looking into timber windows

Although they look good and perform well thermally, timber windows need regular maintenance to keep them in top shape.

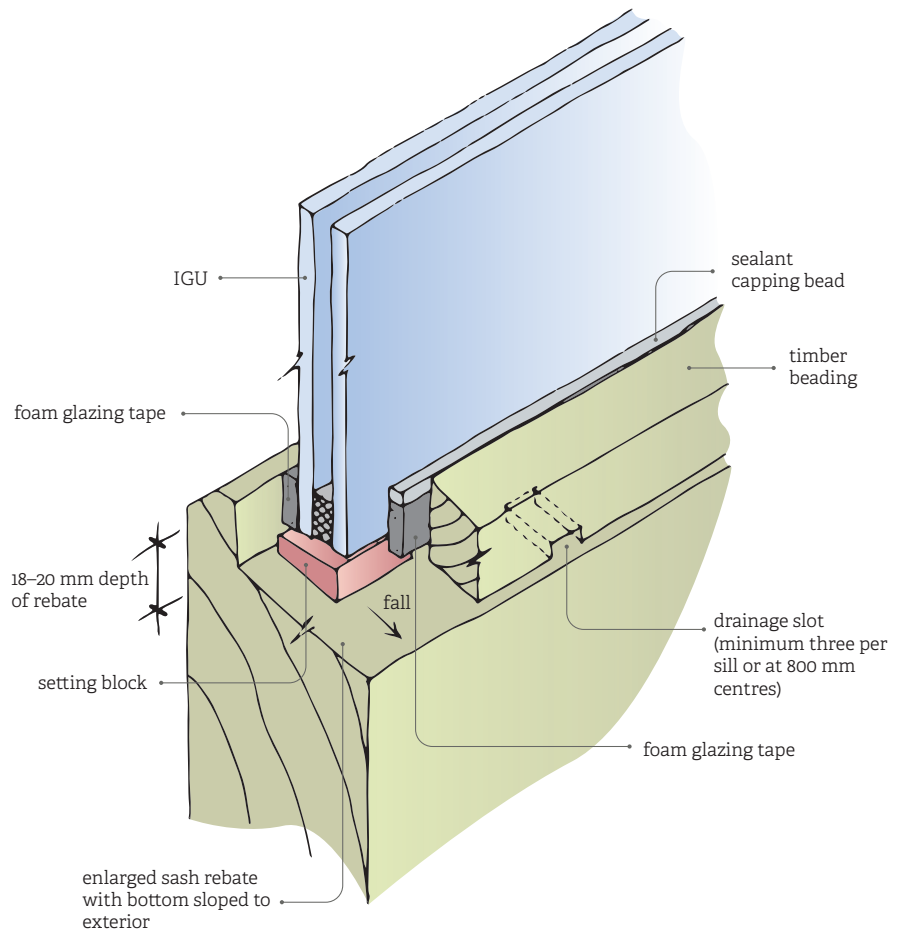
Figure 1: IGU set into enlarged sash rebate.

A major advantage of timber windows is that they can generally be modified to incorporate an IGU, thereby significantly improving the thermal performance of the window. By removing the glass and enlarging the rebates in the timber sash, an IGU can then be set into the rebate – see Figures 1 and 2.

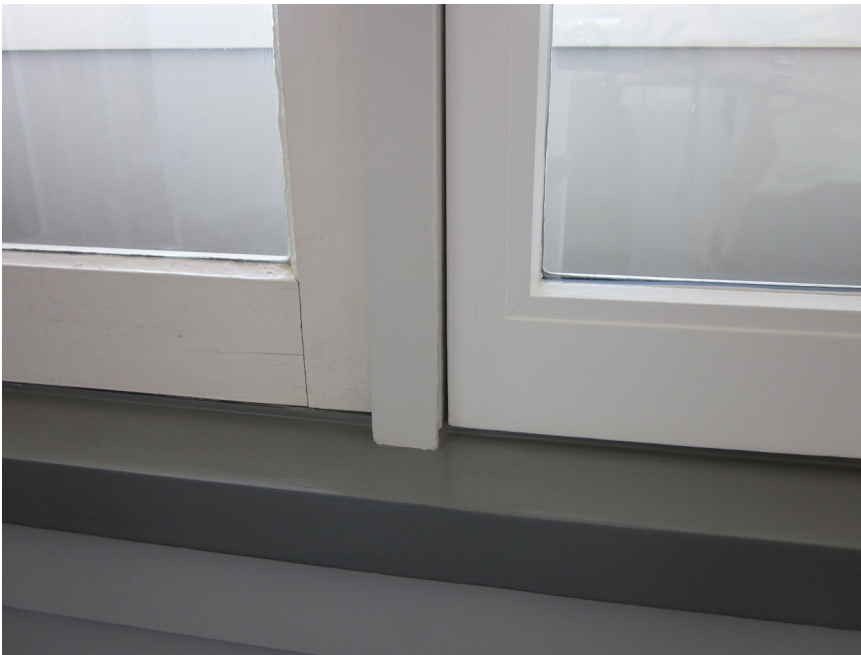
Figure 2: Comparison of casement windows with single glazing (left) and retrofitted IGU (right).
