Detailing windows for brick veneer

NZS 3604 and NZBC E2/AS1 offer limited details for windows in brick veneer but BRANZ has a number of recommendations.

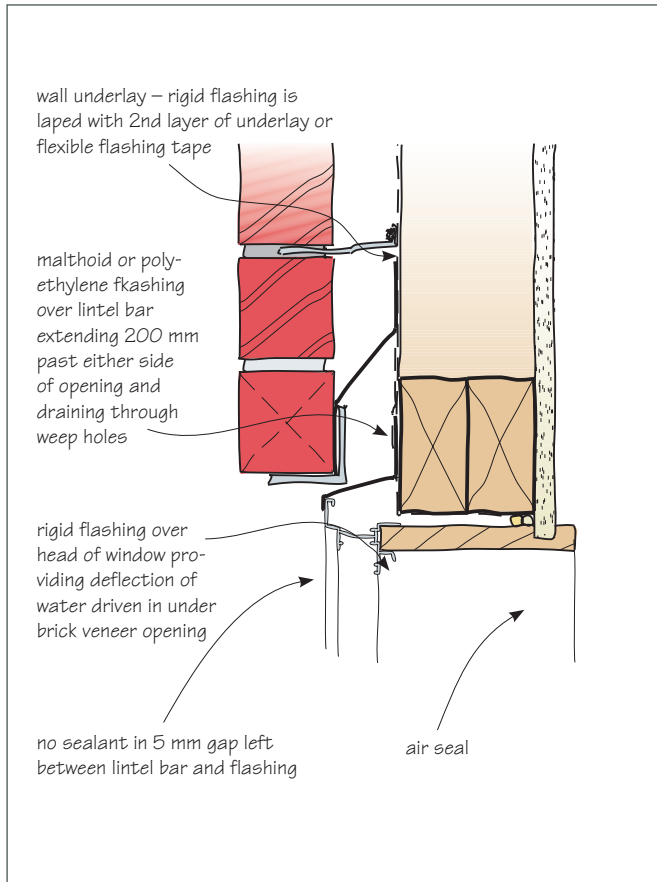
BRANZ also recommends installing a rigid flashing over the window flange, for the full width of the window (without extending 200

mm either side). This will provide deflection against wind-driven rain and hosed water that could get into the gap between the window reveal and head of the framed opening (see Figure 1). One option is to fix this rigid flashing to the structural frame.

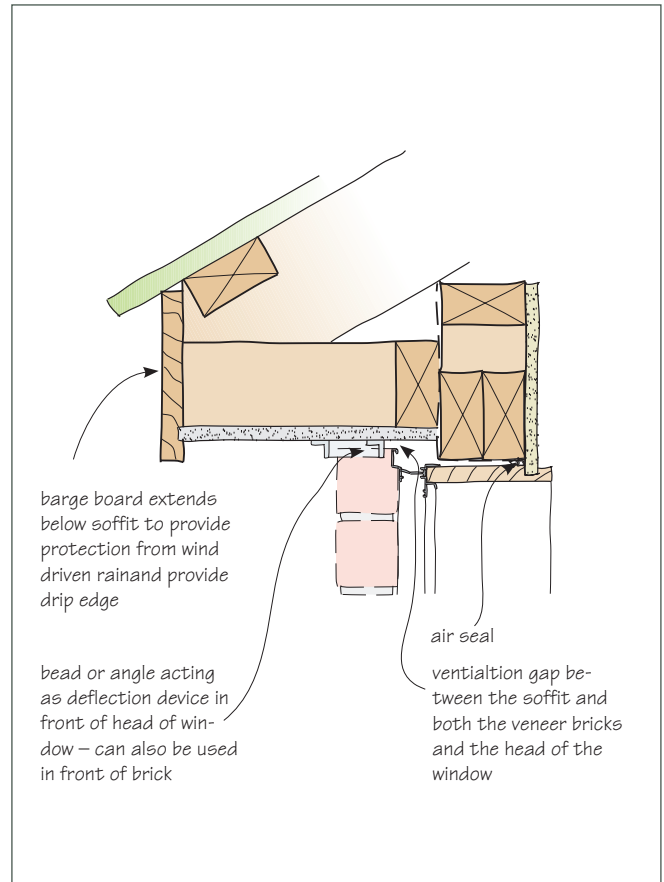
If the window flange is installed up to the soffit, BRANZ recommends installing a deflection device (like a bead or angle) forward of the win-

dow (see Figure 2). A gap should be maintained between the window flange and soffit to still allow the required venting at the top of the cavity.

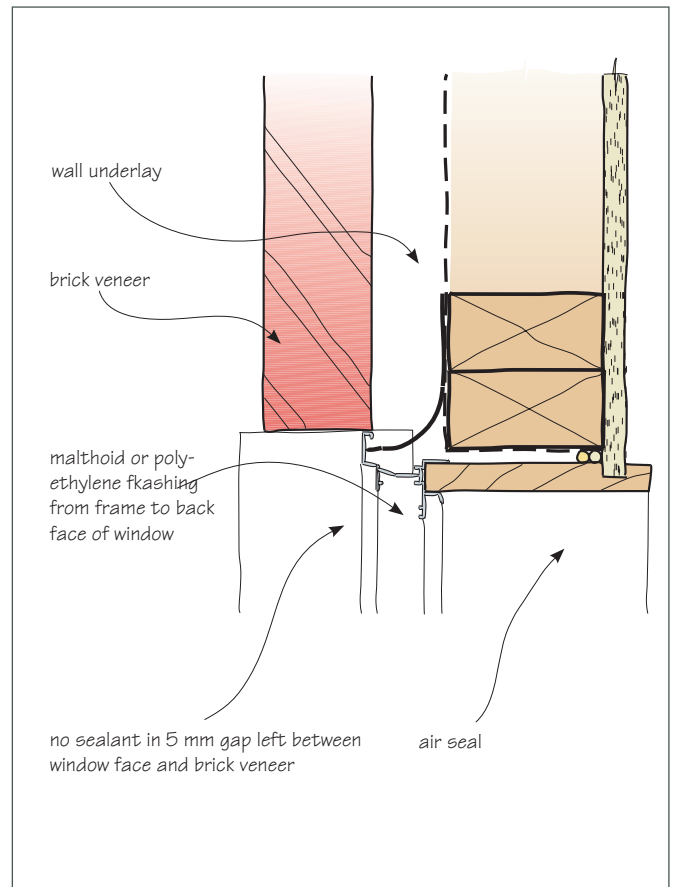
A malthoid or polyethylene flashing should be installed from the structural frame to the back face of the window jamb flange (see Figure 3), to deflect any water driven past the window face from entering the framed opening. It is not necessary to seal the gap between the brick and the window flange.

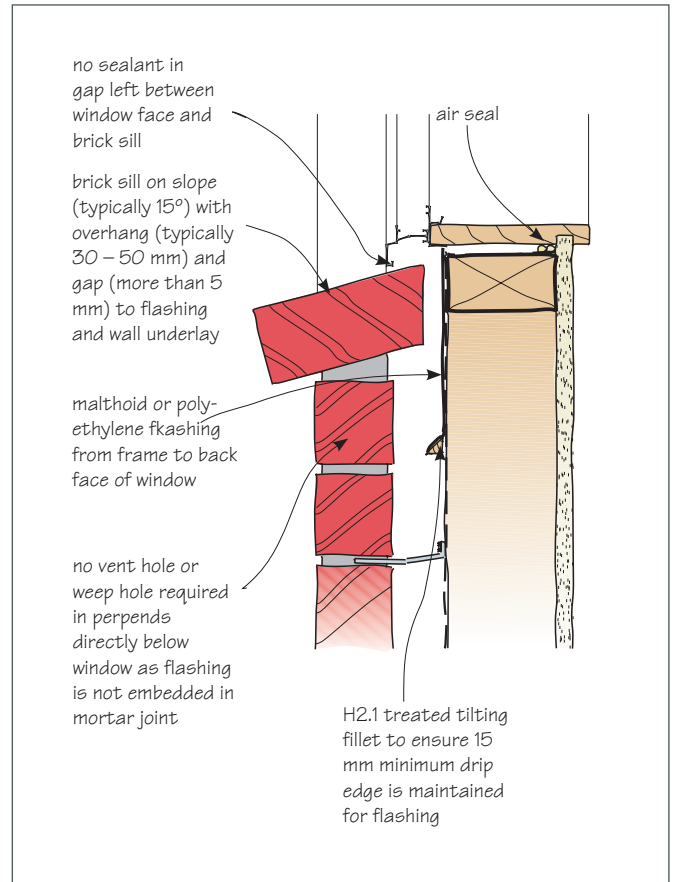
The other option, which BRANZ recommends, is for the flashing to have a drip edge of 15 mm minimum distance from the wall underlay. This directs water away from the underlay, towards the back face of the brick, and down to the weep holes at the bottom of the cavity. A tilting fillet should be installed to maintain the drip edge, as the flashing is otherwise liable to flatten against the underlay over time (see Figure 4).

A malthoid or polyethylene flashing should be installed on the structural frame under the window. One option is to span this flashing across the cavity and embed it in the mortar joint one course below the window sill, with weep holes (acting also as vent holes) above the flashing. However, BRANZ considers this unnecessary because:
