TACKLING COMMON BUILDING PROBLEMS

There are a number of common building problems that are likely to need solving when undertaking renovation design and construction. We take a look at a few, including their solutions.

By Trevor Pringle, ANZIA, BRANZ Principal Writer

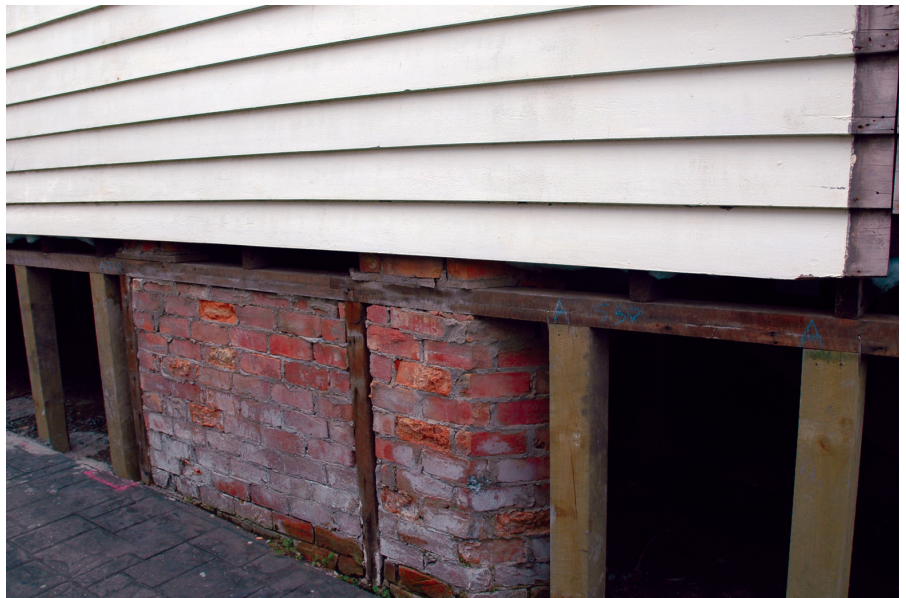
Figure 1: Moisture can be seen rising up through the base of this chimney brickwork. The height of the brickwork minimises the risk of moisture damage to framing.

Buildings built well into the 1940s, and possibly even later, commonly have a brick base for the open fire, copper and coal range (see Figure 1). Typically, these do not have any form of damp-proofing, or if they do, it no longer works.

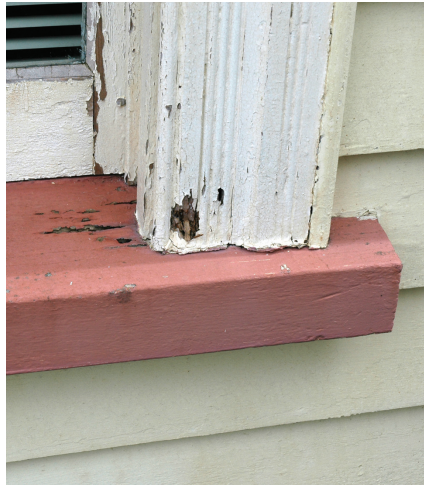
Figure 2: Rot in the sill and facing resulting from water being trapped in the joints and being absorbed into the timber.

- at the foundation/wall framing interface, particularly with a stucco-clad 1930s house
- morticed joints in window sashes
- jamb sill junction in timber windows (see Figure 2)
- mitred corners and scarfed joints in timber weatherboards
- wall framing behind baths, basins and kitchen sink benches
- the base of timber claddings that are close to, or in contact with, the ground
- window reveals, particularly with early aluminium windows without any form of condensation drainage and where MDF reveals remain
- internal gutter support framing
- roof framing around chimney and roof-light penetrations
- floor framing under baths and showers

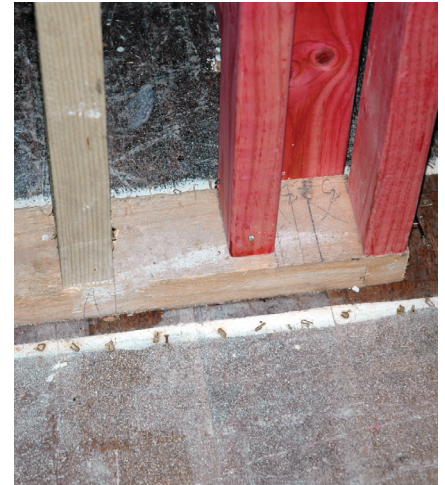
Figure 3: Staggering the new internal wall framing at an external wall corner to accommodate the smaller new framing and allow for the fixing of new linings.

- framing timber – older timber was rough sawn and varied in width and depth, and new framing is significantly smaller and may need to be packed to match, or change the framing at a wall junction (see Figure 3) where the size difference can be masked (some existing framing may need to be replaced to do this)
- profiled internal and external finishing timbers
- cladding profiles
- timber flooring
- corrugated steel – one or two new sheets of metric profile corrugated steel may be able to be lapped with an existing imperial profile to accommodate the difference. This won't work where extensive end-lapping is required and the roof will need to be replaced.

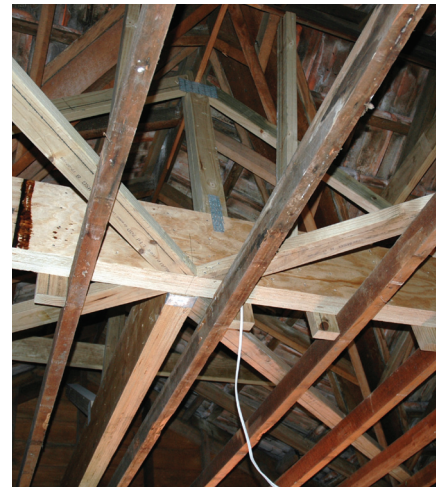
Figure 5: Trussed strongback supporting ceiling joists.

- add strongbacks off which new struts or props are supported (see Figures 4 and 5)
- add beams supported off gable-end walls
- install new rafters or ceiling joists fixed alongside the existing
- add struts under purlins supported off internal loadbearing walls
- replace the existing structure with bigger framing
- replace the heavy roof with lighter roofing material. →

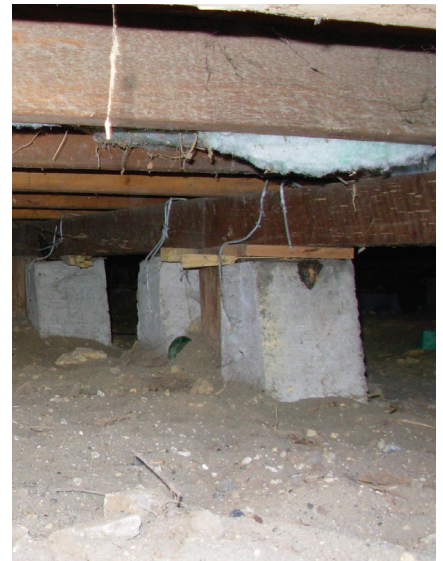
Figure 6: Replacement precast concrete piles with wire ties to the bearers. Original timber piles are also visible.

It is easy to add straps or ties to timber piles but concrete piles will require holes drilled in them to allow a tie wire to be installed (see Figure 6).

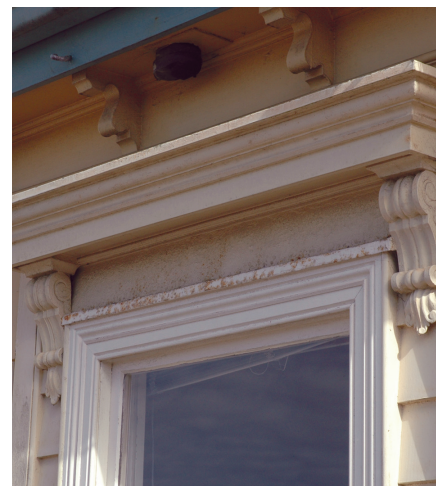
Figure 7: Corrosion of head flashing.

- corrosion of metal components – flashings, fixings, metal roofing and hinges (see Figure 7)
- borer
- mould and mildew, particularly in modern, airtight homes
- seized windows – double-hung and casement sashes unable to be opened because of paint build-up over time
- broken sash cords in double-hung windows
- timber floor and wall framing too close to the ground
- retaining walls that are tilting or cracked
- deteriorated wiring and pipework
- excessive draughts
- lack of insulation
- presence of asbestos in building and finishing materials
- presence of toxic moulds
- presence of lead in paints, flashings and waste pipes.
