# TIMBER TREATMENT HAS JUST GOT SIMPLER

The treated timber framing system that came into effect on 4 April this year allows a single hazard class, H1.2, to be used for all enclosed radiata pine and Douglas fir framing.

By John Harper, Senior Advisor – Building Standards, Department of Building and Housing

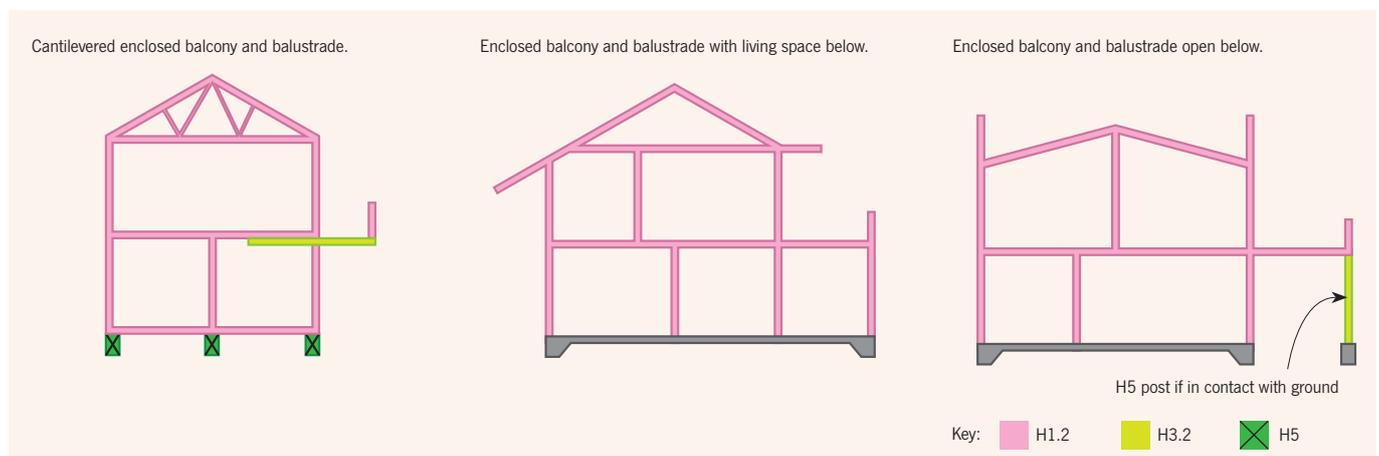
Figure 1: New treatment requirements for timber framing.

Most users of timber can now buy H1.2 framing and use it anywhere enclosed in a building for frames, trusses, floor joists, flat and sloping roofs, skillion roofs and so on. There is, however, one exception – cantilevered deck joists and associated framing must be H3.2 (see Figure 1). All other deck framing and enclosed balustrade and parapet framing can be H1.2 treated.
