# Lateral stability of boundary walls

A BRANZ research project investigated the lateral stability of boundary walls for simple residential structures in the event of a fire.

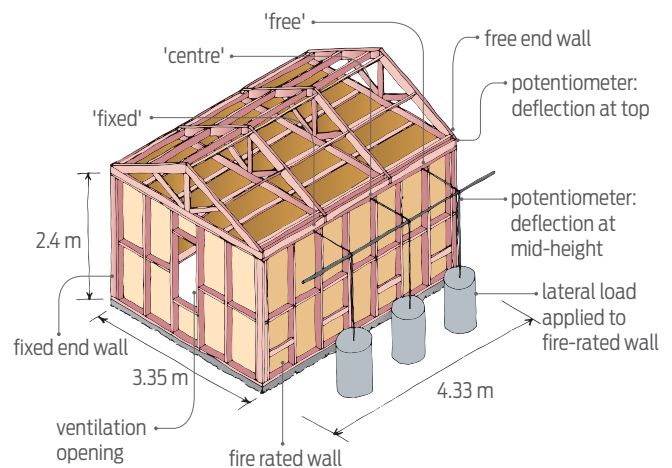
Figure 1: Compartment and lateral loading arrangement used for outdoor experiment – external cladding not shown for clarity.

This was achieved using water-filled drums suspended by a pulley system and cables fixed to the top plate of the boundary wall in line with the trusses (see Figure 1). The lateral load determined for the fire-rated wall was based on the Building Code B1/VM1 option to resist a uniformly distributed horizontal face load of 0.5 kPa in any direction.

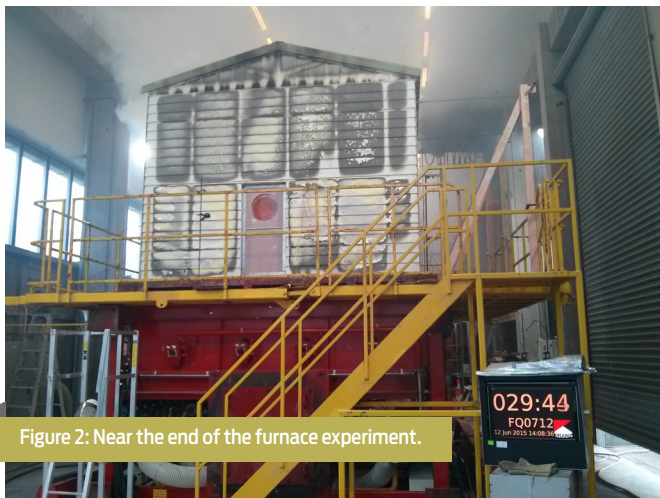
Figure 2: Near the end of the furnace experiment.

In the furnace experiment (see Figure 2), the bottom chord of the roof truss failed at the spliced connection in tension after 30.5 minutes (14.5 minutes after the ceiling failed).

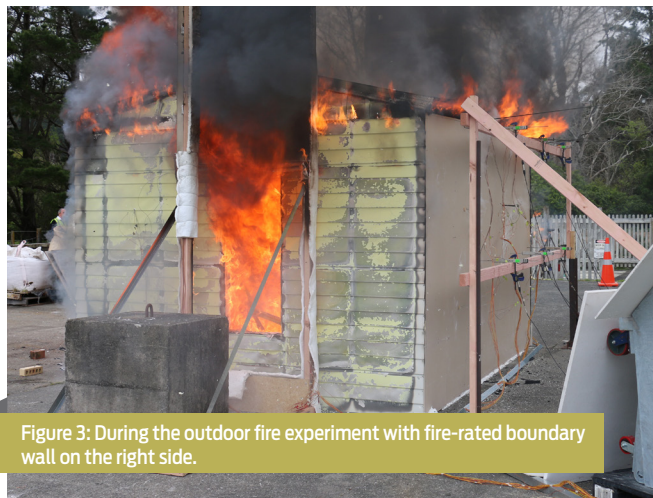
Figure 3: During the outdoor fire experiment with fire-rated boundary wall on the right side.

For the compartment experiment (Figure 3), the bottom chord of the roof truss failed in tension after 28 minutes (16 minutes after the ceiling failed).
