# Character brings challenges

‘Character home’ is a popular descriptor on the real estate ads. But what headaches might be in store when planning to alter or renovate a character home of the 1920s or 1930s?

BY ANN GALLOWAY, FNZIA, ANN GALLOWAY ARCHITECT LTD, NAPIER

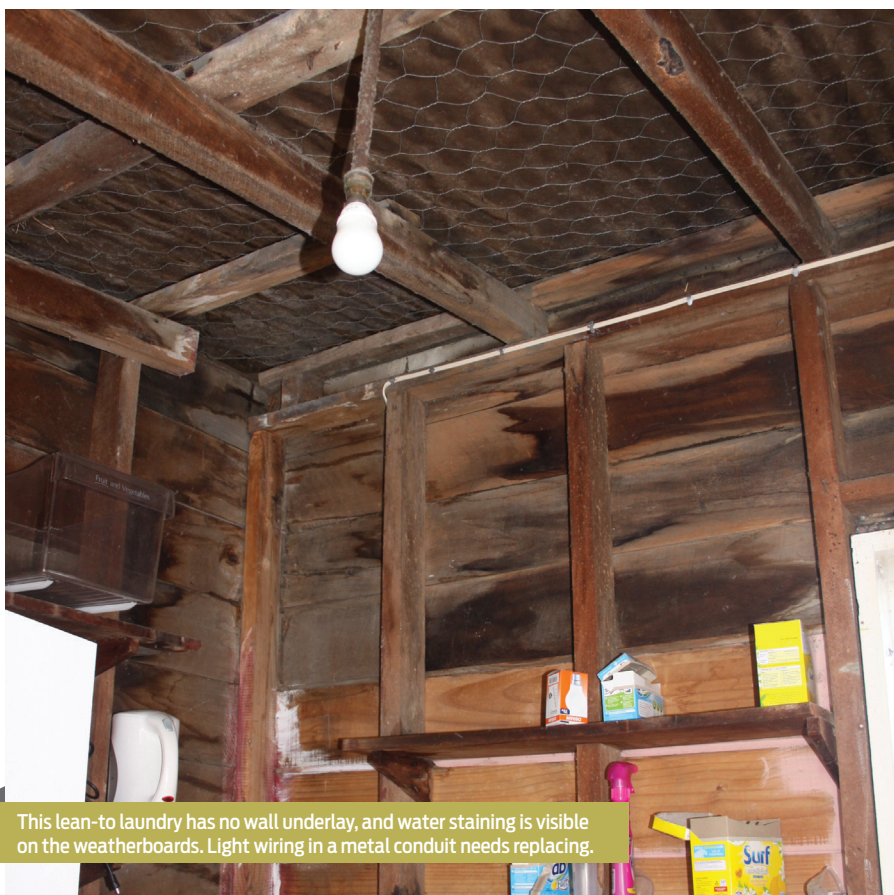
**THE BUNGALOW TYPIFIED** houses of the 1920s with its pitched gable roof, wide eaves, bevel-back weatherboard cladding and rooms opening off a central hallway. Timber-framed walls were built without dwangs, with timber sarking or match lining providing both structural stability and a subsurface for wallpaper. Tongue and groove boarding was used in service rooms.

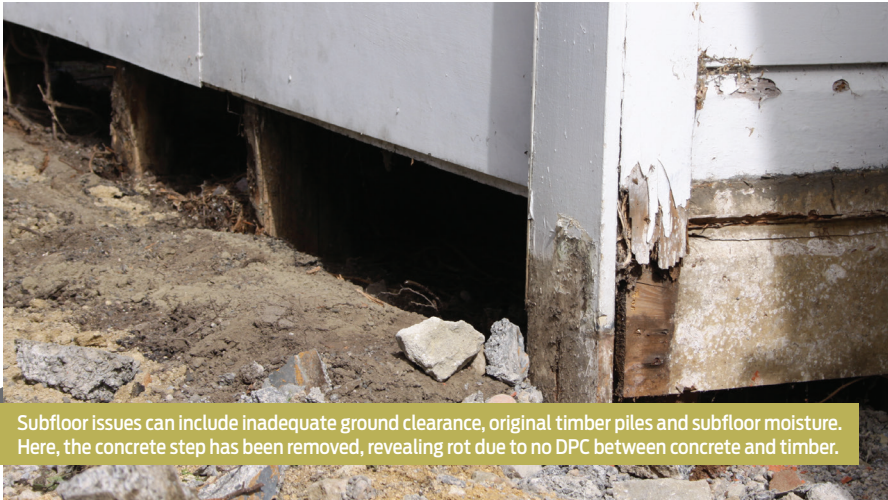
Subfloor issues can include inadequate ground clearance, original timber piles and subfloor moisture. Here, the concrete step has been removed, revealing rot due to no DPC between concrete and timber.

This lean-to laundry has no wall underlay, and water staining is visible on the weatherboards. Light wiring in a metal conduit needs replacing.

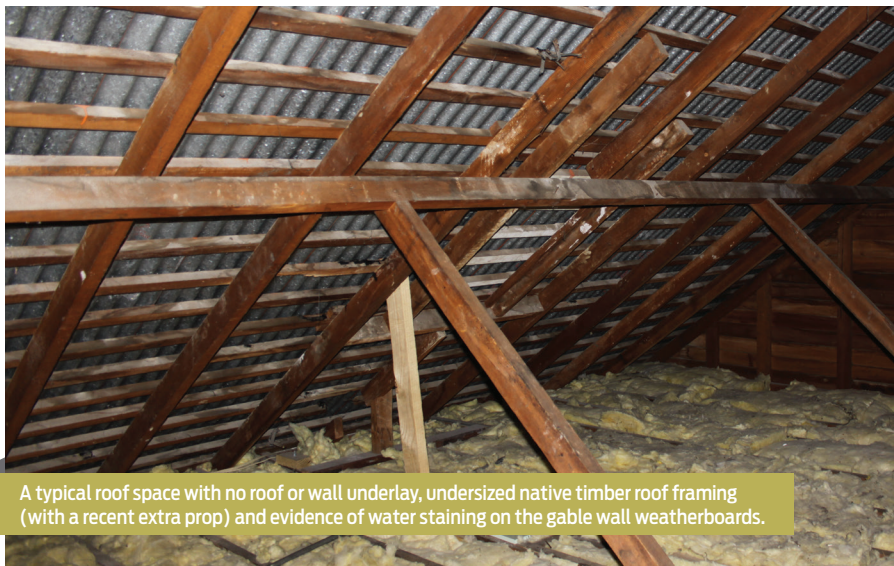
A typical roof space with no roof or wall underlay, undersized native timber roof framing (with a recent extra prop) and evidence of water staining on the gable wall weatherboards.
