# Structurally fixed cavity battens

The larger shank diameter of fixings used to fix weatherboards over a cavity can cause splitting. One way to get around this problem is to fix timber cavity battens directly to the structural framing.

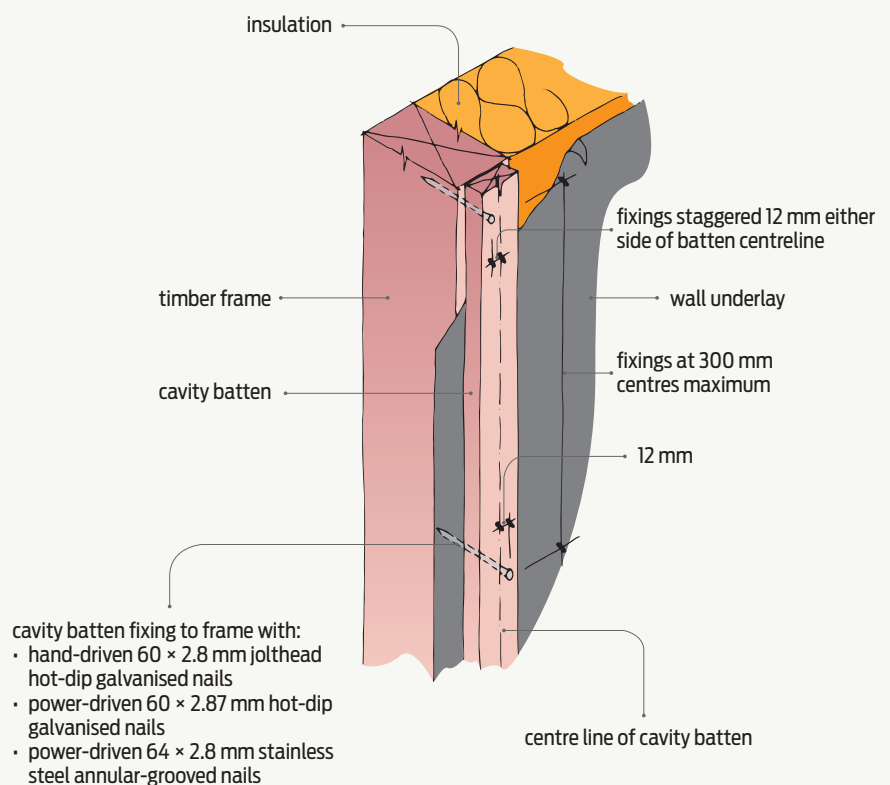
**Figure 1** Fixing for a structurally fixed timber cavity batten.

One way to overcome this potential splitting problem is to fix the timber cavity battens directly to the framing. The battens then become part of the structural frame, which allows the fixings given in Table 24 to be used.
