Under the weather

In response to industry questions, BRANZ recently launched a research project into corrosion rates in vented roof spaces. Two roof spaces have been built in an unforgiving coastal environment and will be monitored.

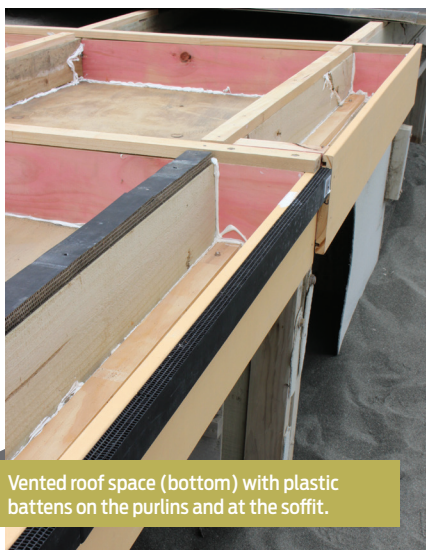
Vented roof space (bottom) with plastic battens on the purlins and at the soffit.

It is envisaged that the front vents especially will clog up with sand. While this phenomenon is worth documenting, we are mainly trying to establish the corrosion rates on the inside, so we will keep the vents as open as possible during the experiment.

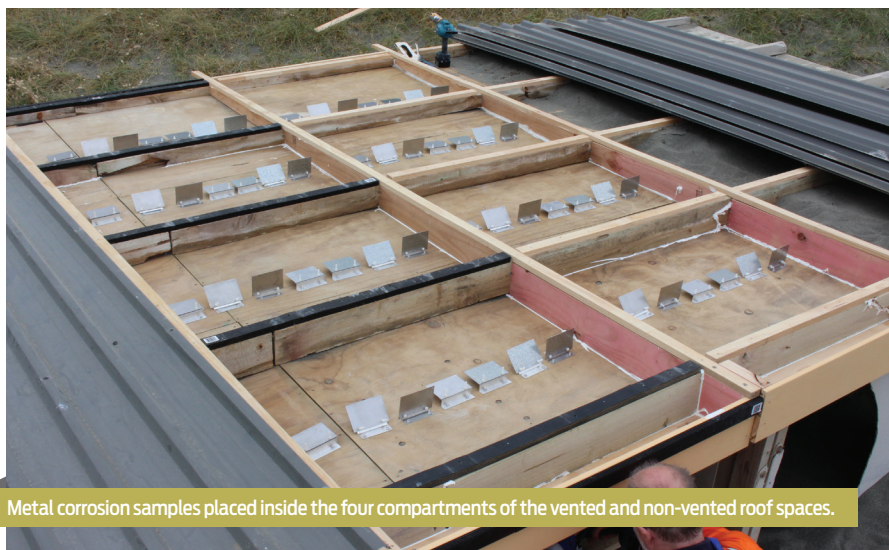
Metal corrosion samples placed inside the four compartments of the vented and non-vented roof spaces.

Twenty-eight exposure samples are mounted in the four compartments of each of the vented and non-vented spaces. They are mild and galvanised steel positioned at 0°, 45° and 90° angles as well as a stainless steel sample included as a reference.

These three installation arrangements represent the most common in-service conditions for metallic components in buildings. Also, they provide very different conditions for salt accumulation and deposition and therefore for atmospheric corrosion-induced failure.
