# Horizontal timber weatherboards

Horizontal timber weatherboards have been a popular cladding material for houses in Aotearoa New Zealand for many years, with an excellent track record for durability when properly installed and maintained. Even when maintenance has been less than ideal, timber weatherboards have sometimes lasted more than 100 years.

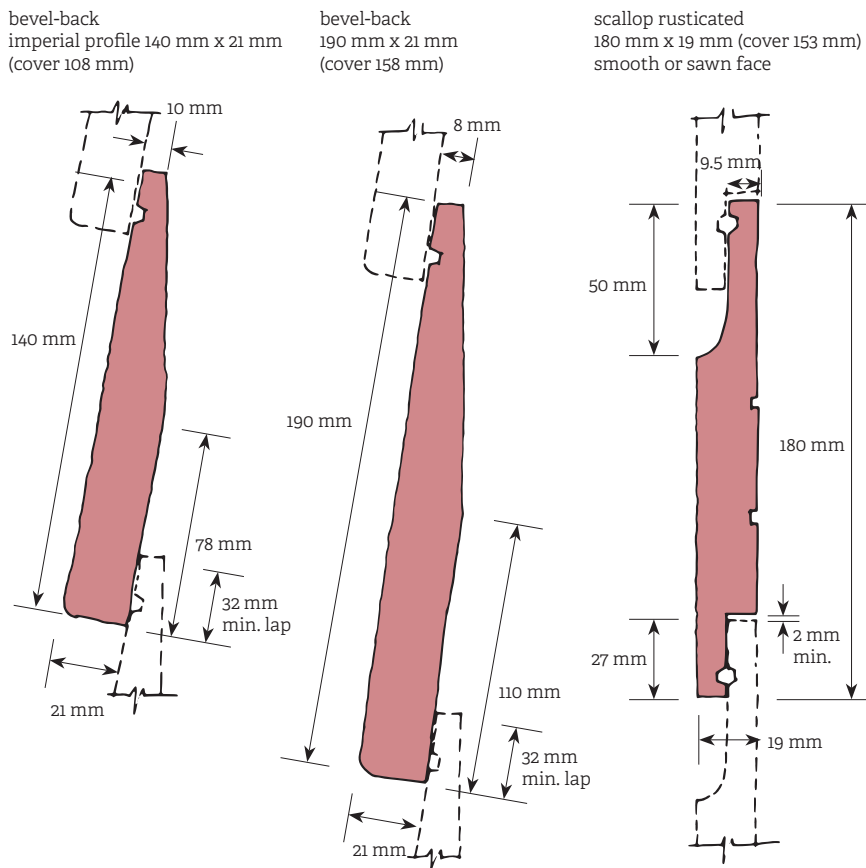
Figure 1: Bevel-back timber weatherboards.

Horizontal timber weatherboards are typically either a bevel-back or rusticated profile (see Figure 1). Standard profiles are described in NZS 3617:1979 *Specification for profiles of weatherboards, fascia boards, and flooring* and BRANZ Bulletin 411 *Recommended timber cladding profiles*.

Rusticated weatherboards have a rebate along their bottom edge that forms the lap over the board below. The reduced thickness of the rebate makes the boards more prone to deformation and splitting, and a minimum 2 mm expansion gap in the rebate must be provided to prevent the timber from buckling (see Figure 1). As rusticated weatherboards have a flat, rear face with a greater board to framing contact, the drying that can occur behind the boards is more limited.

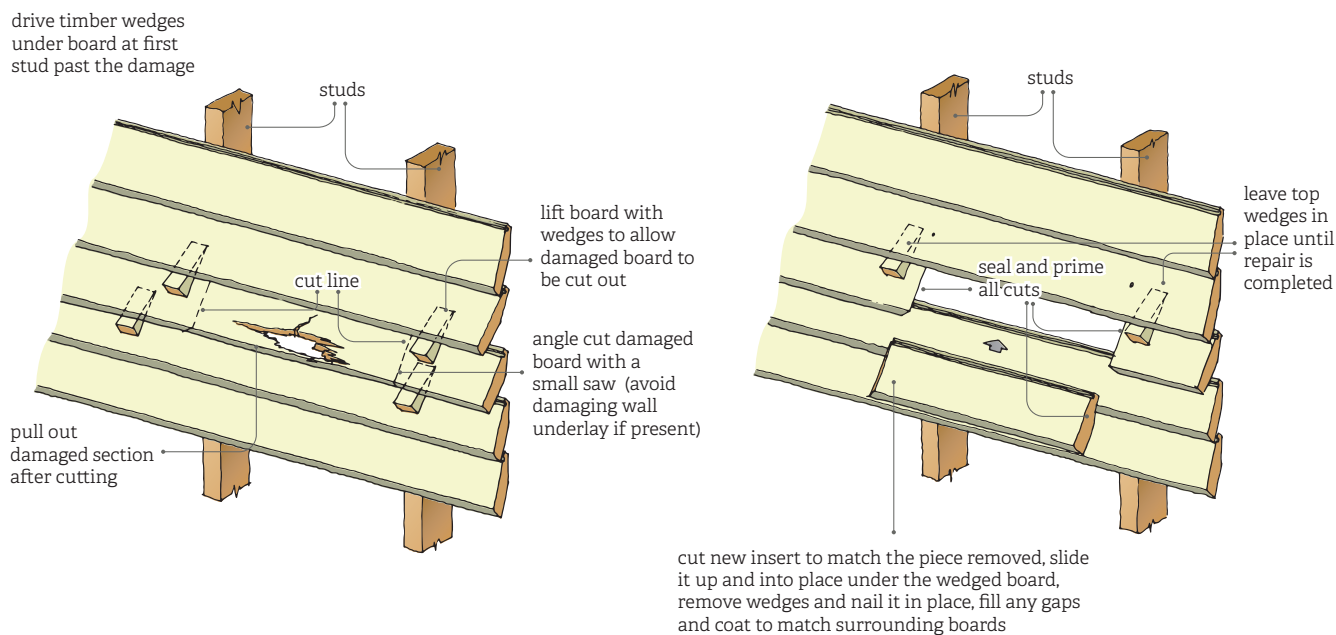
Figure 2: Replacing a rotted section of timber weatherboard.

Rot or decay in timber is generally visible but can also be easily confirmed by prodding the timber with a screwdriver. If the screwdriver goes into the timber easily, the timber is rotten. The rotted section of timber should be removed to at least 1 m beyond the extent of the rot and the cut

sections on both sides of the cut area sealed and primed (see Figure 2). The framing timber should be checked to ensure that the rot has not spread. If it has, extensive repair work is required.
