COATINGS AND EXTERIOR PAINTED SURFACES

Most of the surfaces on homes and buildings are painted or protected by a surface coating. Getting the job done right in the first place and a little basic maintenance can add years to the life of an architectural or decorative paint system.

By **Danusia Wypych**, Technical Manager, Resene Paints Ltd

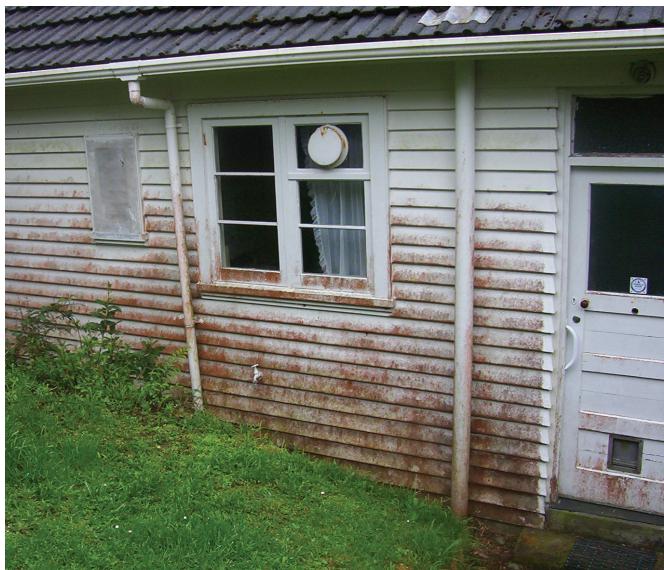
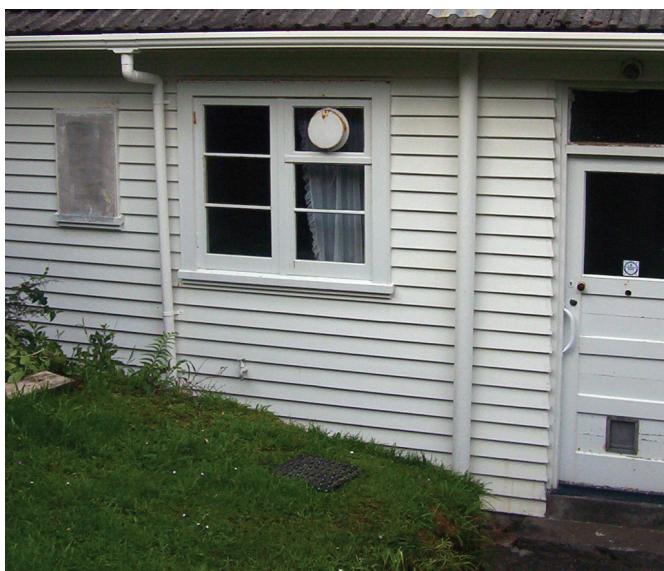
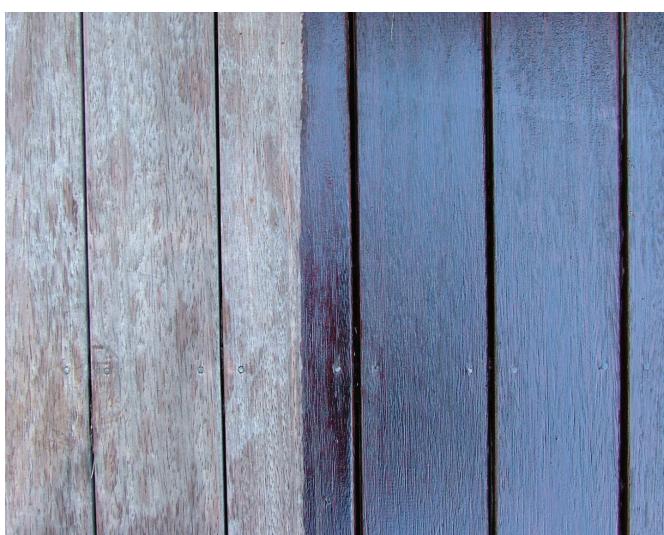
Before and after: Washing paint, stains and other exterior coatings not only maintains the appearance of the surface, it also removes contaminants that can interact with the coating and compromise the surface beneath. (Photos courtesy of JT Propertywash.)

It's important that houses are washed each year to maintain the appearance of paint finishes and to remove any build-up of salt deposits, bird droppings, mould and other contaminants that can interact with surface coatings. Salt-blown areas that are not washed by the rain need particular attention, and if these areas require repainting, it needs to be undertaken after thoroughly washing and preparing the surfaces.
