BUILDING HISTORY

by Nigel Isaacs, BRANZ
Principal Scientist

Using the trees – slab and log houses

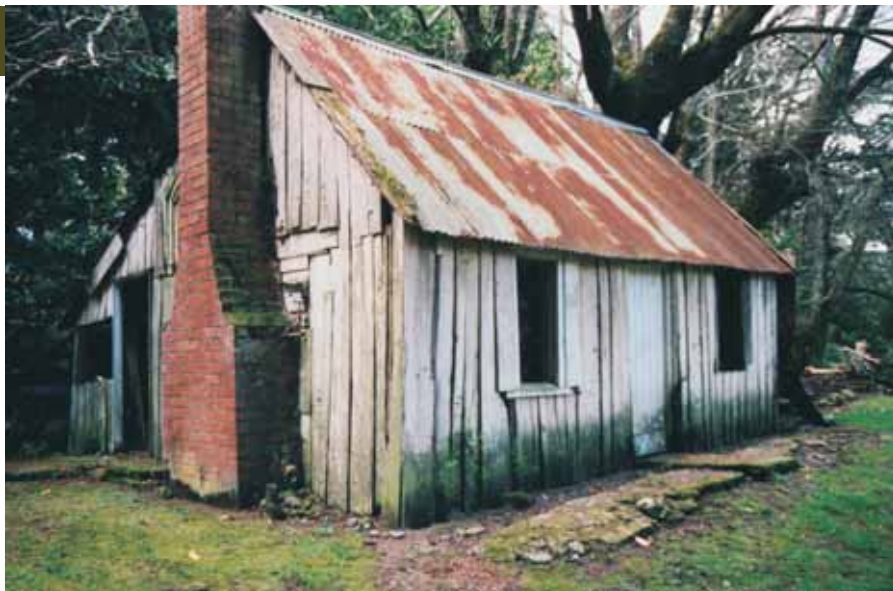
Sayer wood-slab whare at Dalefield, near Carterton.

kahikatea could be readily split into slabs about 2 inches (50 mm) thick and 10–12 inches (250–300 mm) wide. The slabs were largely self-supporting, though often assisted by a light timber frame, as in the Sayer whare.

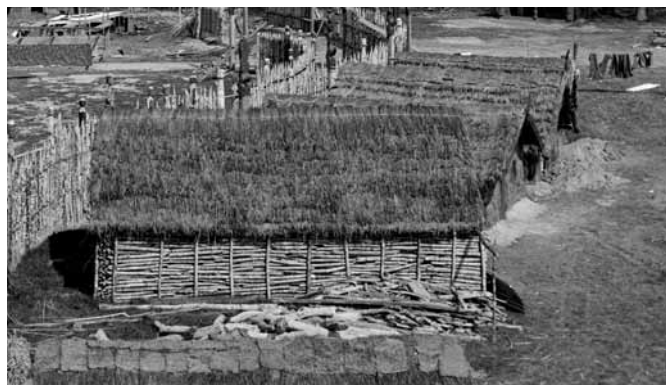
Log-walled whare at the Christchurch Exhibition in 1906. Photograph by James McDonald, Museum of New Zealand Te Papa Tongarewa (ref C.001712).

New Zealand did not seem to adopt the 'log cabin' so popular in frontier North America, although a few examples were found such as that at Wilkin River. Cultural beliefs coupled with active insect life (two-toothed borer) led to the development of a more readily repairable wall system – laying logs horizontally but supported between a series of double upright poles. These poles could be small round wood or even ponga logs. A lining of raupo, toetoe reeds or cabbage tree leaves could then be used to reduce draughts and create a warm interior.

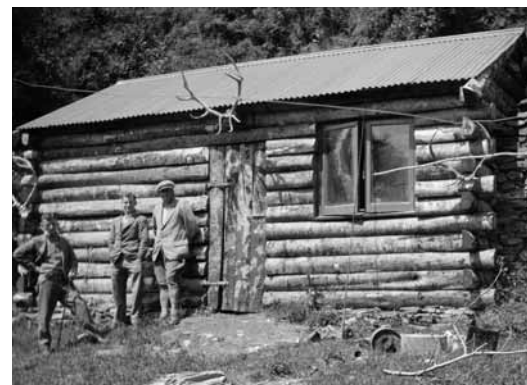
'Log cabin' at Wilkin River, Lake Wanaka. Photograph by George L. Adkin, Museum of New Zealand Te Papa Tongarewa (ref B.023521).
