Slab-edge insulation

BY TREVOR PRINGLE,
ANZIA, BRANZ PRINCIPAL
WRITER

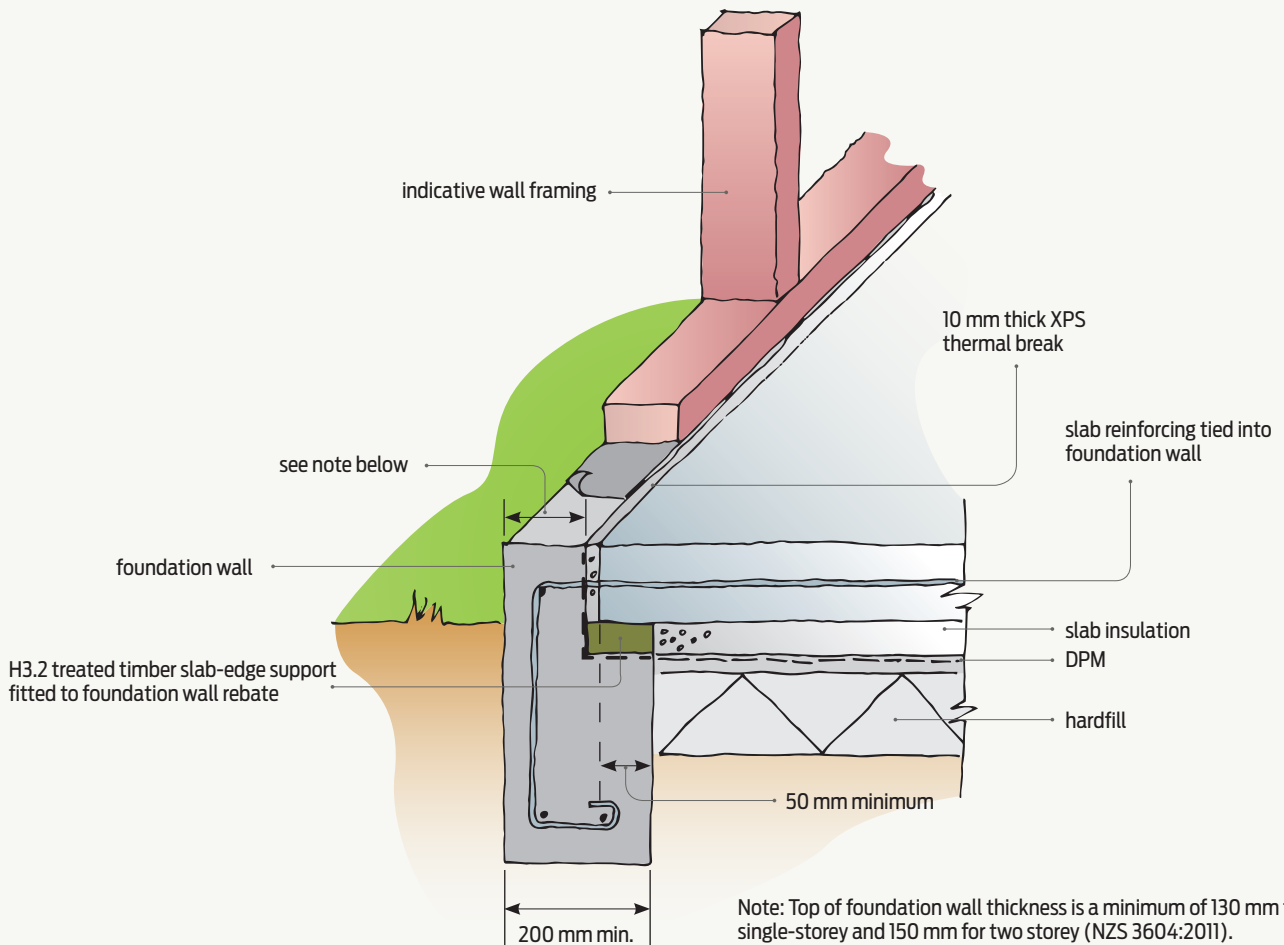
The revised detail uses a 10 mm thick XPS (extruded polystyrene) thermal break between the foundation wall and the slab edge (see Figure 1). This gives the required thermal break performance (R0.35) and allows the slab edge to be supported on the foundation wall rebate. ■

The aim of the change is to minimise the width of the thermal break. This is so that the steel reinforcing remains restrained within the concrete

during an earthquake while achieving the required insulation value of the thermal break. The original detail used a 45 mm wide timber thermal break, which may have allowed the steel to flex across the width of the timber when loaded.
