HOPWOOD CLOCK TOWER – ECI ENABLES INNOVATION

The team that successfully refurbished the Hopwood clock tower used early contractor involvement (ECI) to minimise risk and drive innovation in this landmark Pathfinder project in Palmerston North.

By Peter Cunningham, Chief Executive, Construction Clients' Group

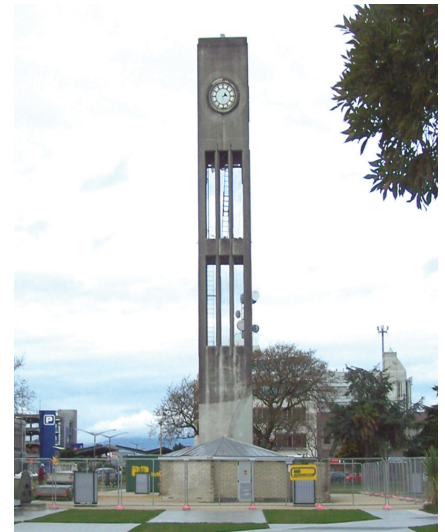
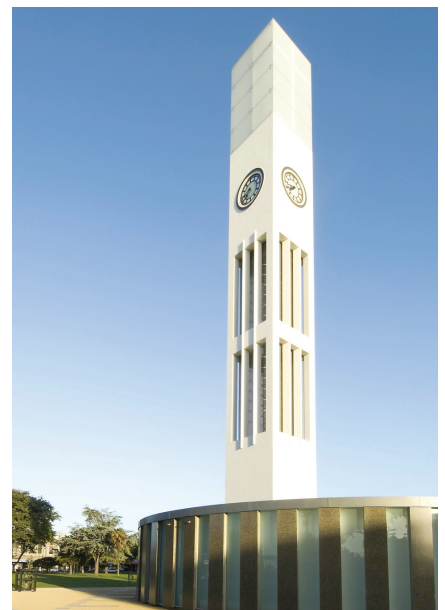
Hopwood clock tower before refurbishment (top) and afterwards (bottom).

Following an assessment of the existing structure, it was decided that the clock tower needed to be demolished and renewed. The ECI process was used to identify the most appropriate methodology. The prefabricated section solution chosen saved money and shaved up to 6 months from the timeframe.

The original 35-tonne lantern section was cut away from the original structure. The lantern was then renovated using LED lights and self-cleaning glass before reinstating this iconic structure.

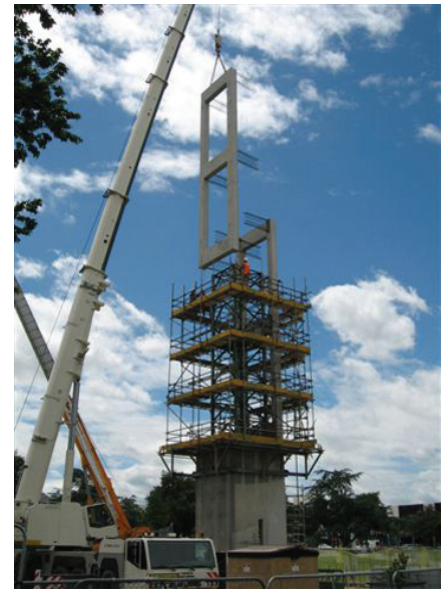
Precast sections being put in place.

The precast sections were hung from tower crane sections constructed on the inside of the

tower and acted as a scaffold as the new panels were put in place and sealed. Constructing the tower from the base to the top section took 3 weeks.

An innovative solution to a common issue was to hang the precast panels for the clock tower from tower crane sections. These acted as a scaffold frame while the panels were joined and sealed. Clip-on and cantilever scaffolding was also used during this process.

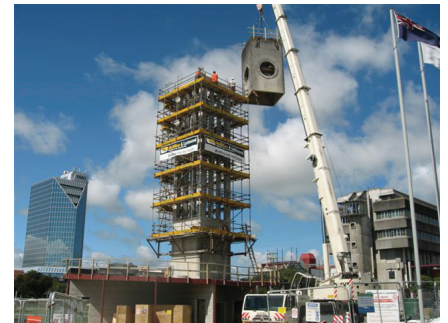
Replacing the renovated lantern section.
