New homes dripping

Modern building practices often result in more airtight dwellings. BRANZ looked at two new builds with internal moisture problems and found issues could have been avoided with efficient ventilation.

BY IAN COX-SMITH, BRANZ BUILDING PHYSICIST

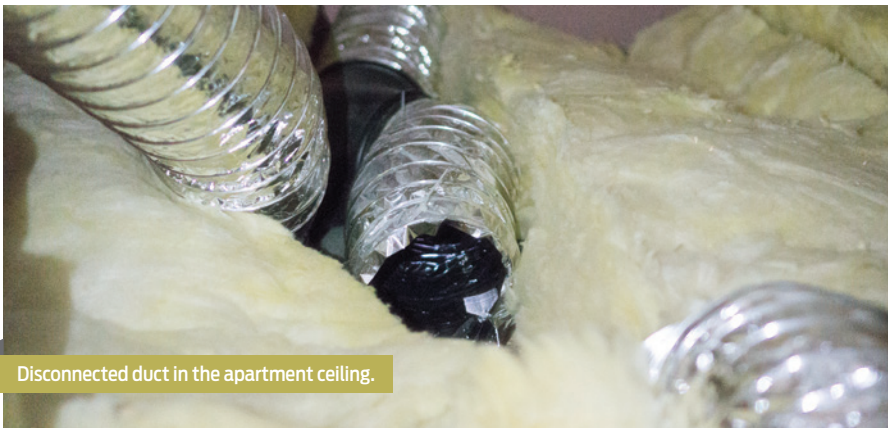
Disconnected duct in the apartment ceiling.

- The air being extracted by the bathroom fans was in most cases so low that it was difficult to detect at the outlet. That, and finding a disconnected duct in the ceiling of one apartment, suggests there was no commissioning step following installation of the fans and ducting. With no access to the ceiling of the house and some ceilings in the apartments, it would have been very difficult to rectify mistakes discovered after the buildings were completed.

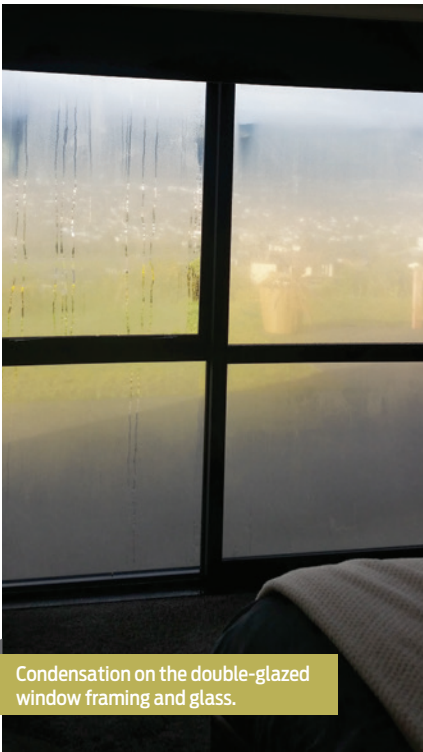
Condensation on the double-glazed window framing and glass.

In both instances, the buildings were less than a year old, and despite having double glazing, they were experiencing an almost continuous layer of condensation on the

window framing and the glass (see cover). The occupants were having to mop up moisture on the window sills daily and were finding some mould growth on walls and ceilings.

In both these cases, the moisture was accumulating because there was a continuous daily cycle of condensation on the windows at night and evaporation back into the internal air during the day.

A lot of the condensation was spilling over into the carpet where it would have been difficult to mop up each morning.
