Keeping in character

BY BRUCE SEDCOLE,
ANZIA, BRANZ TECHNICAL
WRITER

In *Build 186 Houses ripe for renovation*, we talked about renovating and refurbishing New Zealand character homes. Now, here is a closer look at some of the common tasks you may have to address.

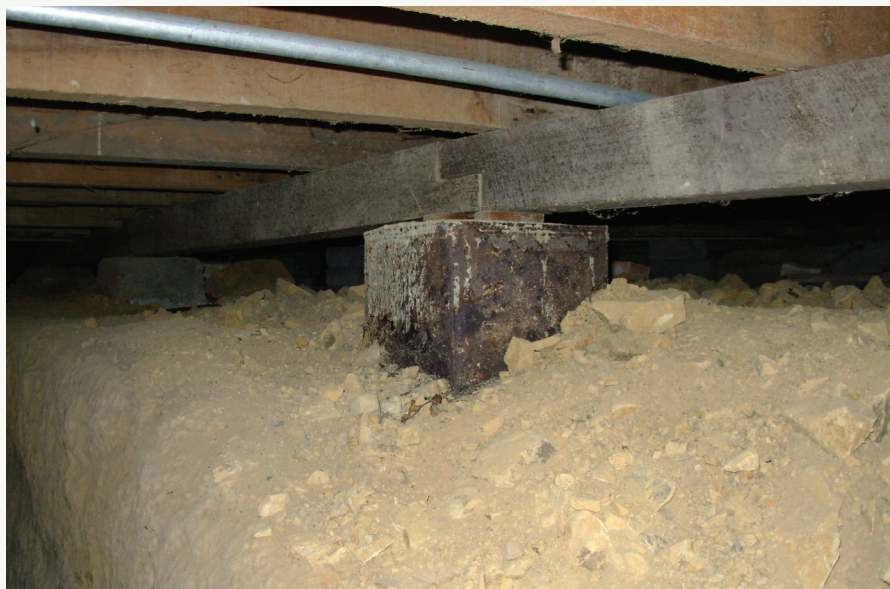
Start with the piles – in situ concrete piles cast in kerosene tins can still be found.

There may have been subfloor repairs since the building was originally constructed, and replacement treated pine piles or precast concrete piles may be present. Early in situ concrete piles can still be sometimes found cast in kerosene tins – approximately 300 mm square – with the rusting remains of the tin left as permanent formwork. These will all have to be evaluated to see if they are fit for purpose and meet current standards.
