Common maintenance issues

Property inspections carried out when a house goes on the market regularly turn up a whole range of problems. Some could have been found and fixed earlier if regular home maintenance had been carried out.

SARAH SYMON, DIRECTOR, REALSURE

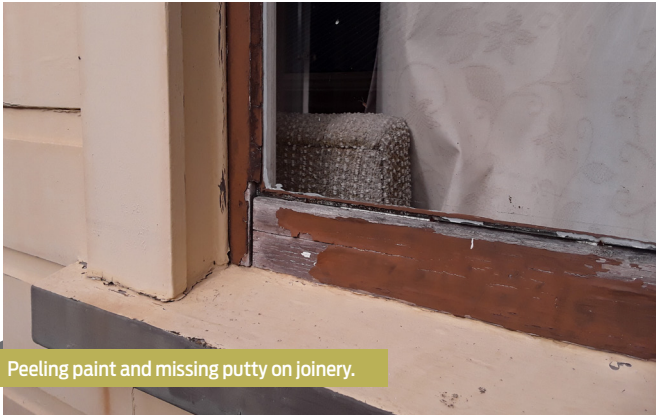
Peeling paint and missing putty on joinery.

In timber joinery, rot damage, cracked putty, peeling paint, rusted hinges and flashings, sticking or binding joinery and gaps or warped joinery are common defects.

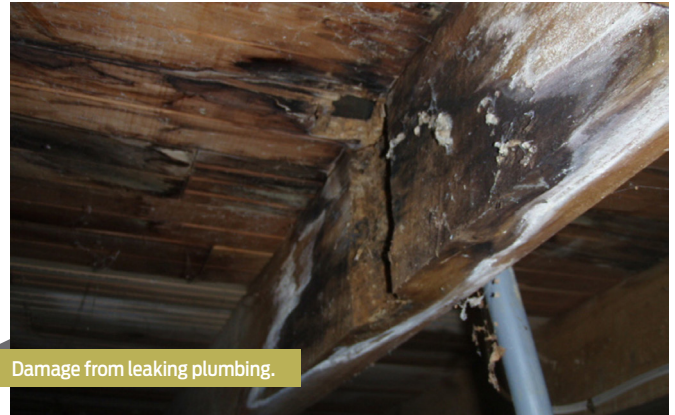
Damage from leaking plumbing.

Rusted out pile to bearer fixings, wet timber framing, leaking plumbing, damaged flooring beneath wet areas or joinery and damp ground are also common. Damp ground can often be associated with paths built up against foundation vents restricting airflow, causing the dampness or even directing water into the foundation area.

Internally, moisture and mould are the most notable maintenance defects. Leaking showers are a common issue, whether caused by a lining, screen or plumbing defect or failure.
