WHEN PIPES FAIL ...

We like to think the pipes in our house are good for the life of the house, but experience tells us this is not always the case.

By Eric Palmer, Technical Manager, Master Plumbers, Gasfitters and Drainlayers NZ Inc.

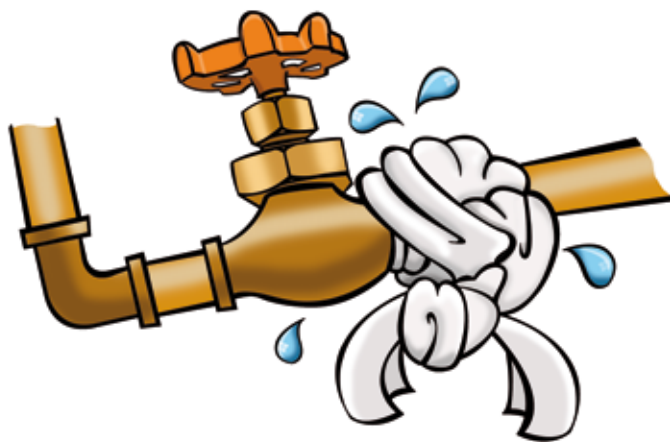
Failure of first-generation polybutylene pipes and fittings is common.

It is not inevitable that old polybutylene systems will fail. The extent of replacement after a failure is a matter of judgement. Prudent advice is to replace everything that is readily accessible, e.g. in the roof space or the sub-floor space. Opening up the walls to replace droppers to fixtures means the room will need substantial redecorating. Perhaps replacement of that piping can wait for a scheduled redecoration.

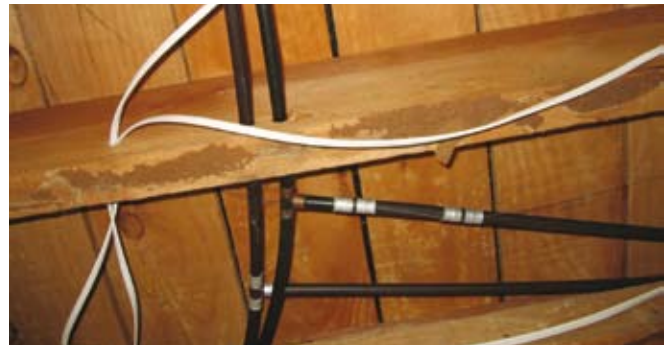
Earlier repairs had already been made to these pipes but they failed again

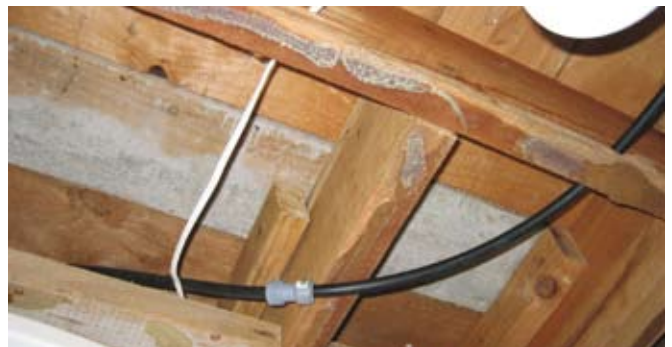
Temporary fix to pipe in ceiling. Leaks caused the ceiling in this room to collapse.
